CURTISS P-40  
BULLETINS

**ESSCO INC.**  
426 WEST TURKEYFOOT LAKE RD.  
AKRON OH 44319  
330-644-7724/FAX 330-644-0886

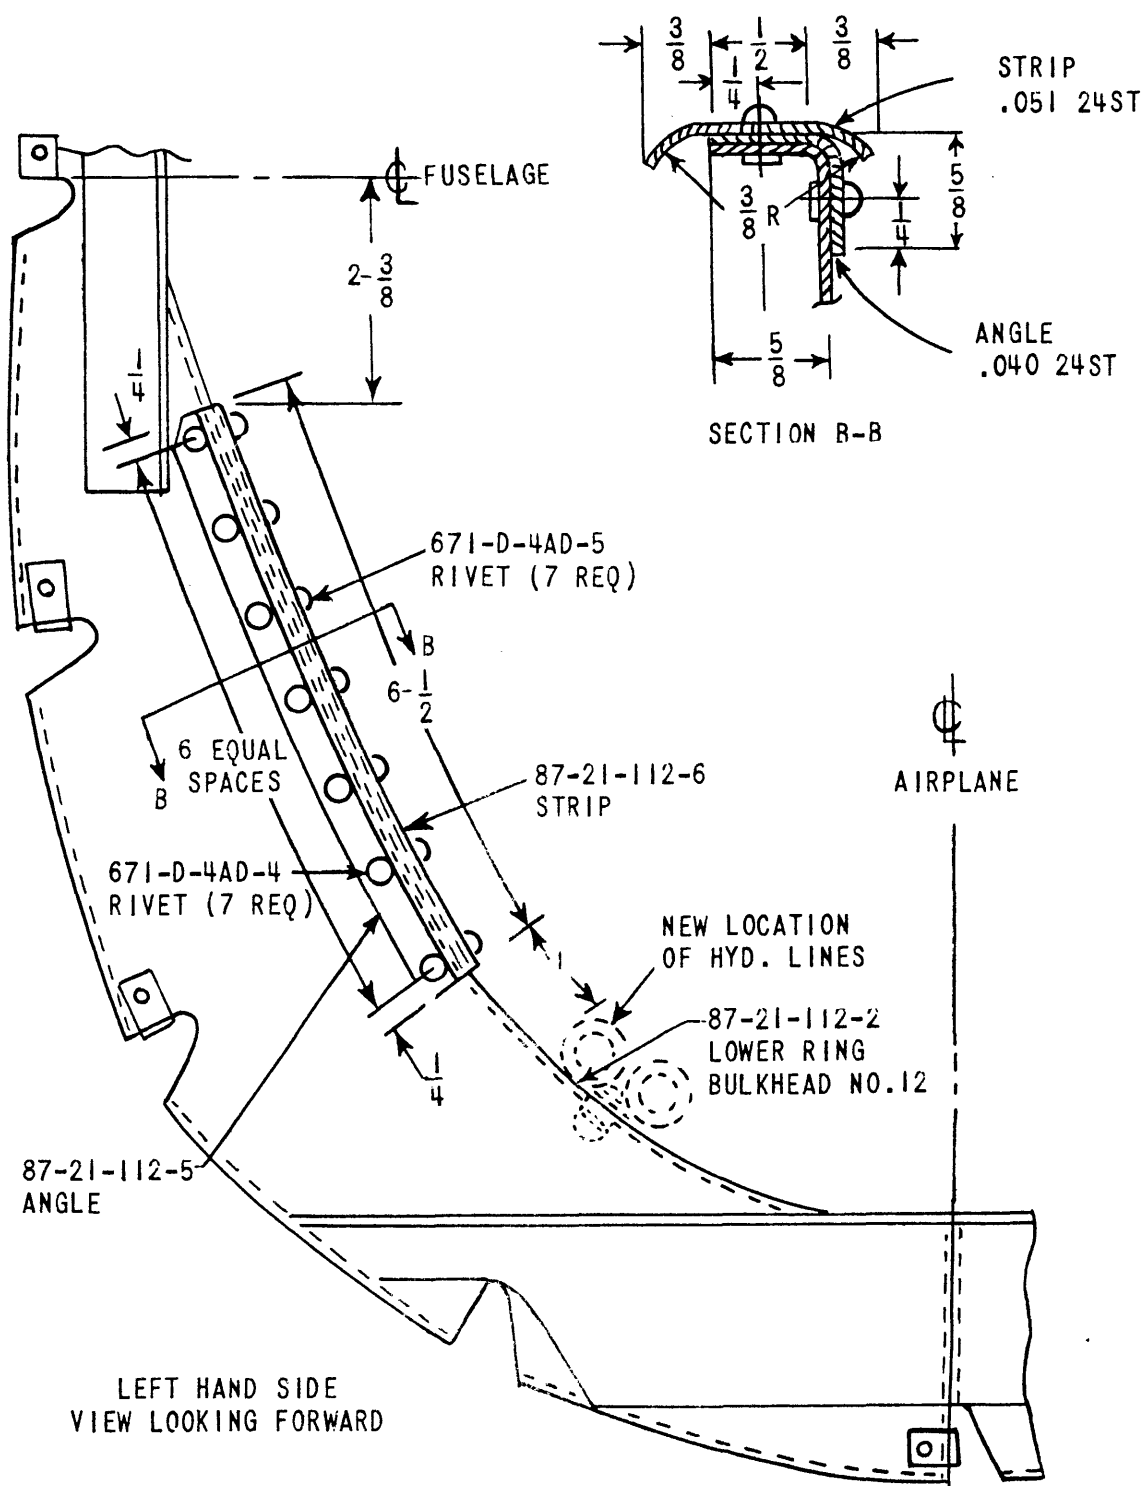
1. To reduce possible damage to the fuselage bulkhead caused by whipping of the tail wheel steering cable during flight, to provide a repair method for fuselage bulkhead in event damage has occurred, and to reduce possible rudder cable failure, the work directed in paragraph 2. will be accomplished on P-40 series airplanes listed below.

Figure 4 - Reinforcement of Fuselage Bulkhead, Station 12 (RP-40, RP-40B, RP-40C, and RP-40G.)

c. CHANGE "C," REPAIR METHOD FOR FUSELAGE BULKHEAD STATION NO. 12 (RP-40, RP-40B, RP-40C, AND RP-40G).

(6) Cut another strip, either stainless steel or Alclad, approximately 1-1/2 x 6-1/2 inches and bend down edges as in section B-B of figure 4.

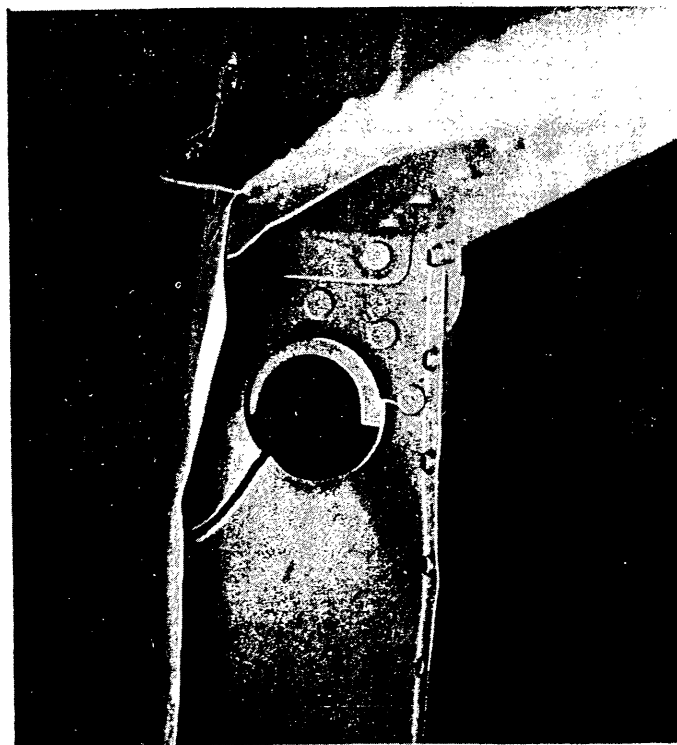
Figure 2 - Rudder Beam Failure

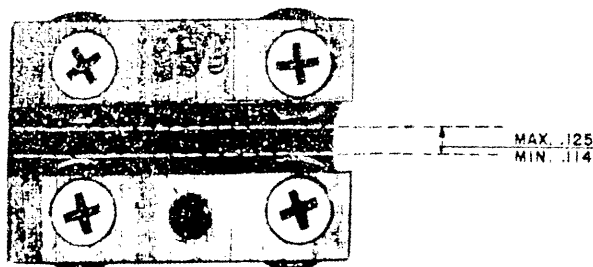
Figure 1 - Showing Permissible Tolerances on Truck Assembly

b. Check four truck assemblies for tight fit on the track. On new truck assemblies, check the gap between the top and bottom rollers for the following tolerances, maximum .125 inch, minimum .114 inch. (See figure 1.) Check the inboard face of the truck extrusion to ascertain if it has a smooth flat surface. If the truck assemblies appear to be satisfactory and the fit on the tracks is slightly loose, it is permissible to close the gap by bending the truck extrusion SLIGHTLY in a convex direction. (See figure 2.) This may be required, due to slight track wear which will occur after a number of service hours. If the gap of the new roller is excessive, discard the roller. Also discard the roller if the extrusion face is concave in shape.

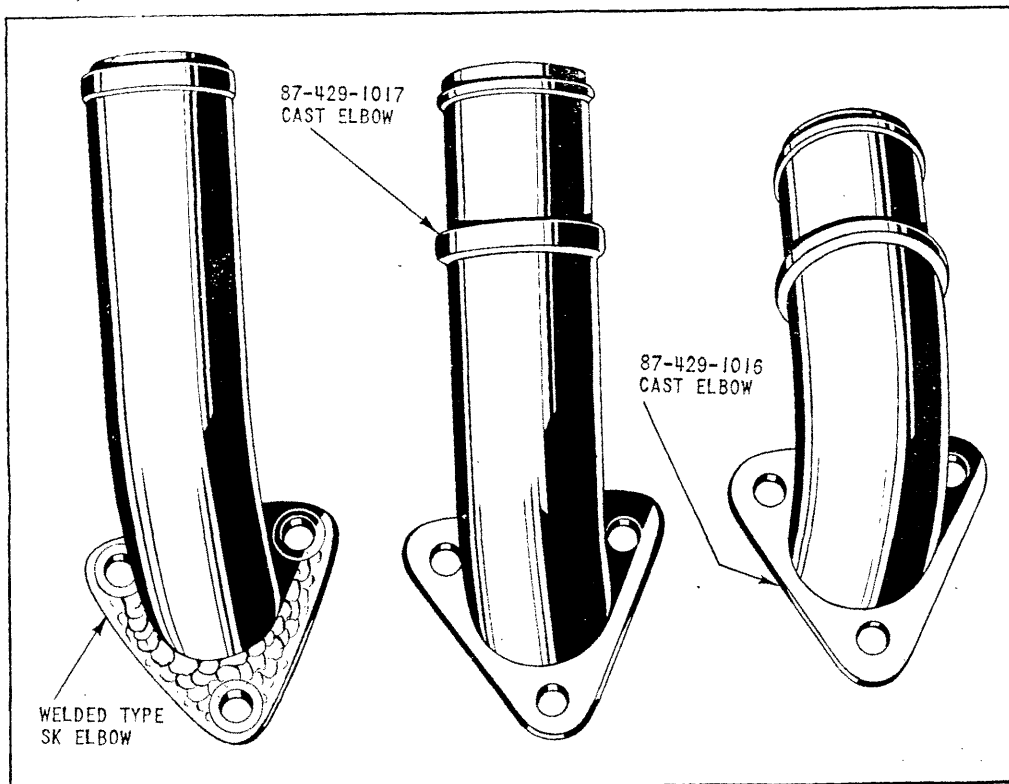
Figure 1

- a. Remove bottom cowling.
- b. Inspect oil system installation for elbow, part No. SK-6699, located on the scavenger pump outlet, and elbow, part No. SK-6700, located on the rotary valve inlet. (See figure 1.)
- c. If old elbow, part No. SK-6699, is installed, replace as follows:
  - (1) Drain the oil system.
  - (2) Disconnect oil line, part No. 87-429-1002-43, from elbow, part No. SK-6699, located at the scavenger pump outlet on the lower right-hand side of the engine.
  - (3) Remove elbow, part No. SK-6699, by removing the three attaching nuts, part No. AN960-516.
