CURTISS P-40  
BULLETINS

**ESSCO INC.**  
426 WEST TURKEYFOOT LAKE RD.  
AKRON OH 44319  
330-644-7724/FAX 330-644-0886

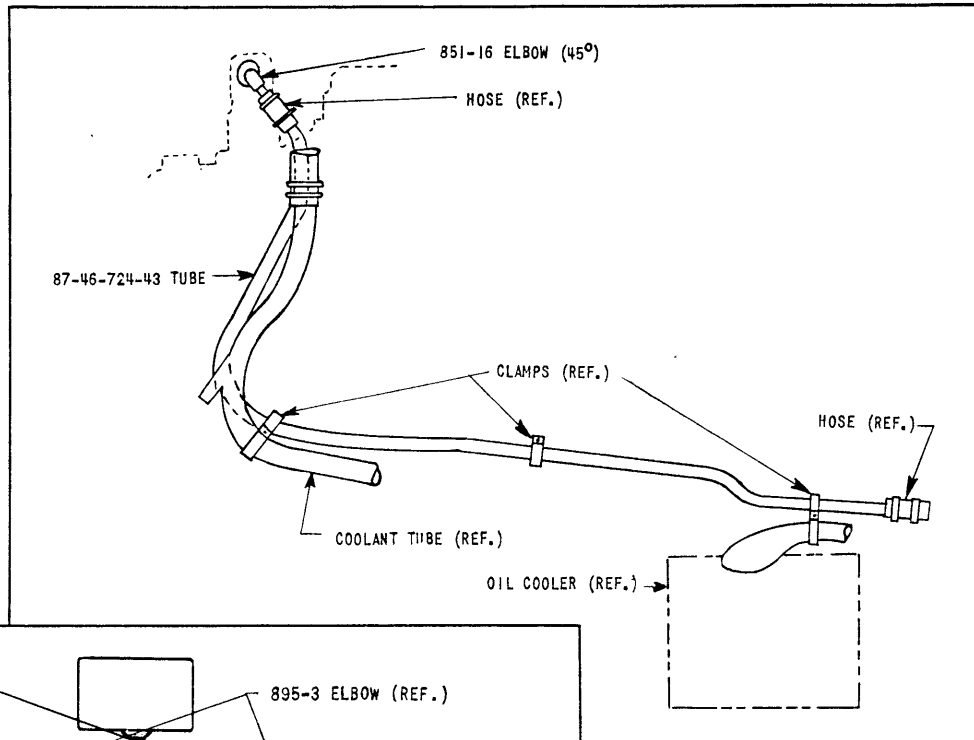
Figure 1 - Installation  
of Engine Breather  
Vent Tube

horizontal line of the airplane. (See figure 1.) Attach rubber hose from the removed tube to the new vent tube, part No. 87-46-724-43, and install vent tube as shown in figure 1. Connect rubber hose to elbow, part No. 851-16, and connect the vent tube to the rubber hose above the oil cooler using the original clamps. Support the vent tube to the coolant line, engine mount, and oil cooler, using the original clamps. (See figure 1.) Attach cooler thermostatic wire to newly installed vent tube using tie string as in the original installation.

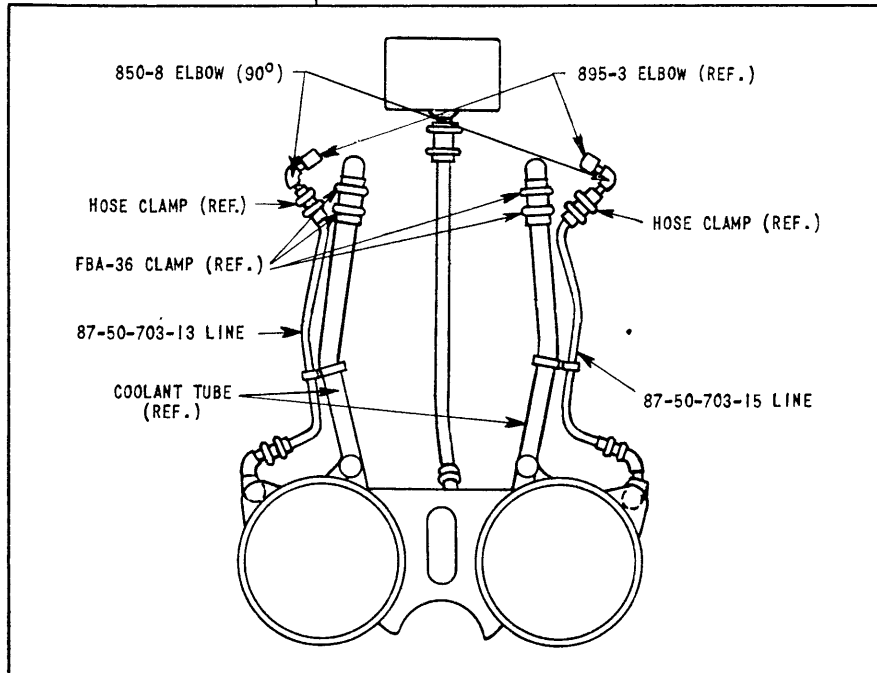
Figure 2 - Modification  
of Coolant Vent Lines

elbows, part No. 853-8, from the 90-degree elbows, part No. 895-3, and install 90-degree elbows, part No. 850-8, in their place. Bend the coolant lines, part Nos. 87-50-703-13 and -15, in order to match with the 90-degree elbows just installed, and attach the lines permanently, using original hose and clamps. (See figure 2.)

(6) Loosen clamps, part No. FBA-36, at the hose connections where the coolant tubes are attached at the front of the left and right cylinder banks of the engine. Rotate the clamps so that the adjusting screws point inboard and retighten the clamps. This is done to eliminate interference with the filter boxes to be installed. (See figure 2.)

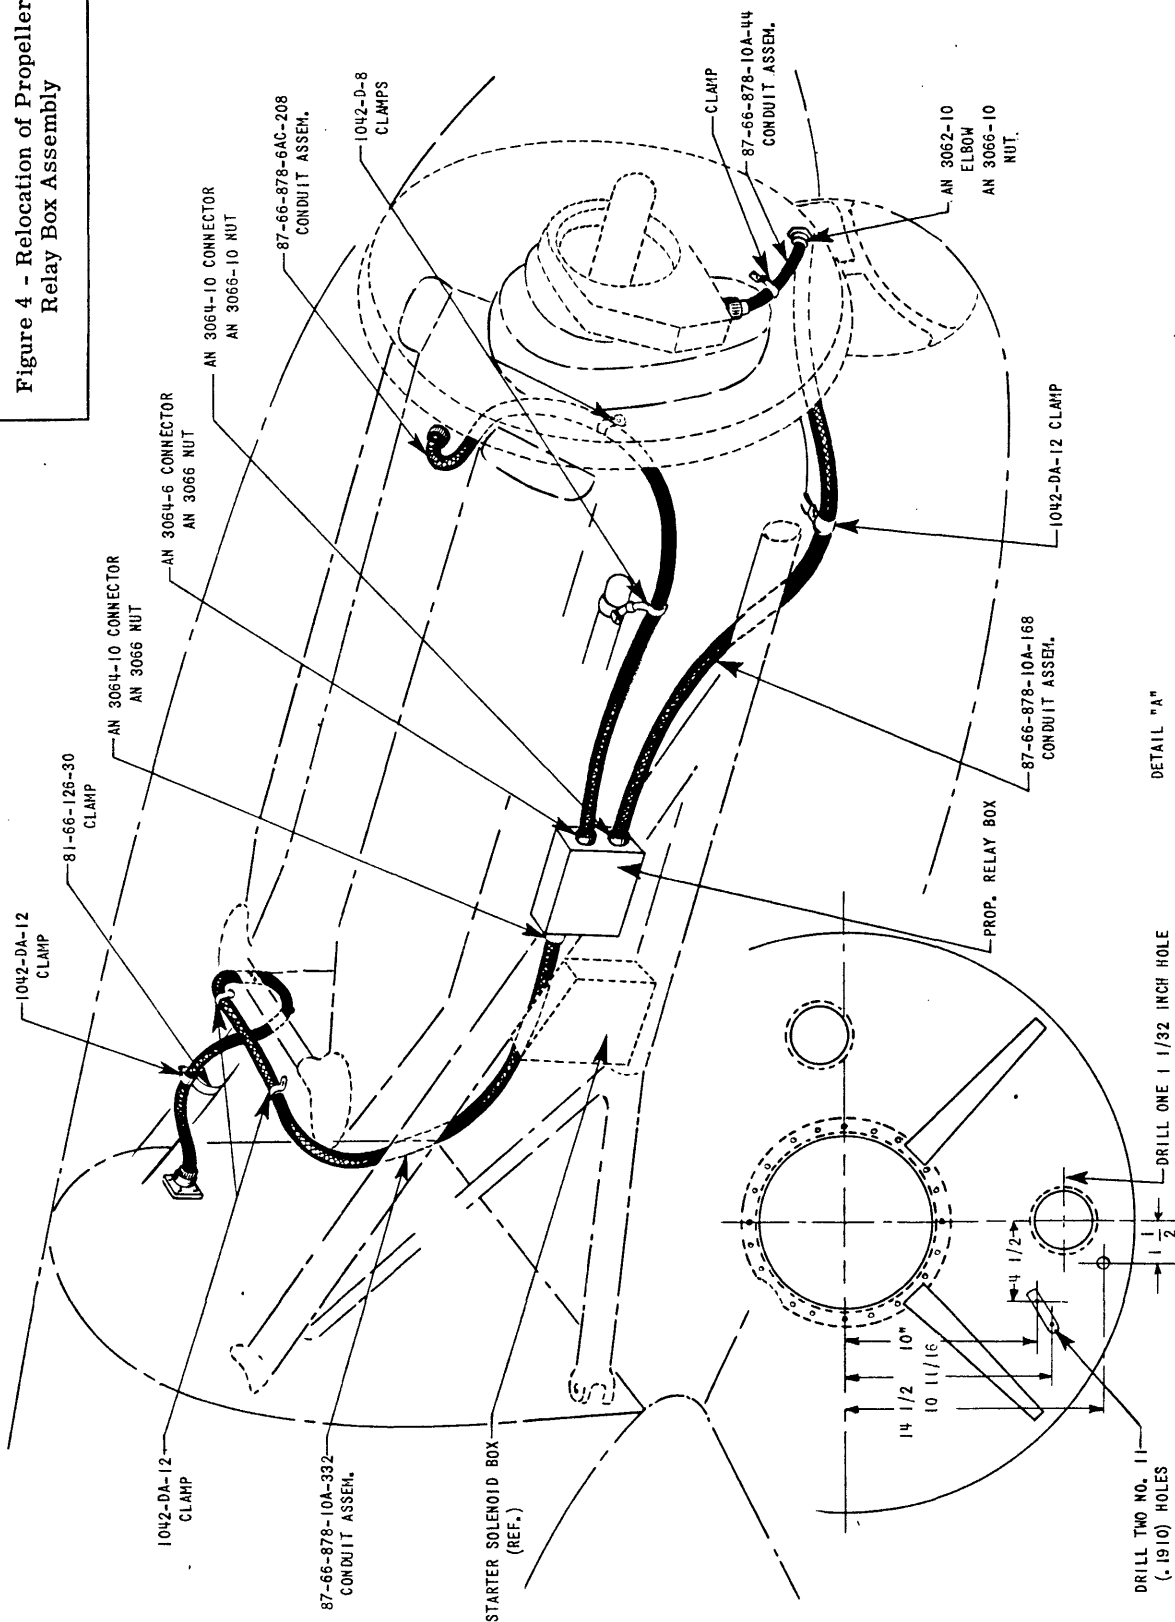
Figure 4 - Relocation of Propeller  
Relay Box Assembly

(8) Remove the two screws, washers, and nuts, holding bracket on the face of the forward engine cowl bulkhead, which previously held circuit in place, and replace it where the two new No. 11 (.1910-inch) holes have been drilled, using two bolts, part No. AN3-4, two washers, part No. AN960-10, and two nuts, part No. 365-1032. (See figure 4, detail "A.")

(12) Remove the two screws that connected the removed conduit to the aft portion of engine as indicated in figure 4 and secure conduit assembly, part No. 87-66-878-10A-332, to the engine with two clamps, part No. 1042-DA-12, and replace the screws.

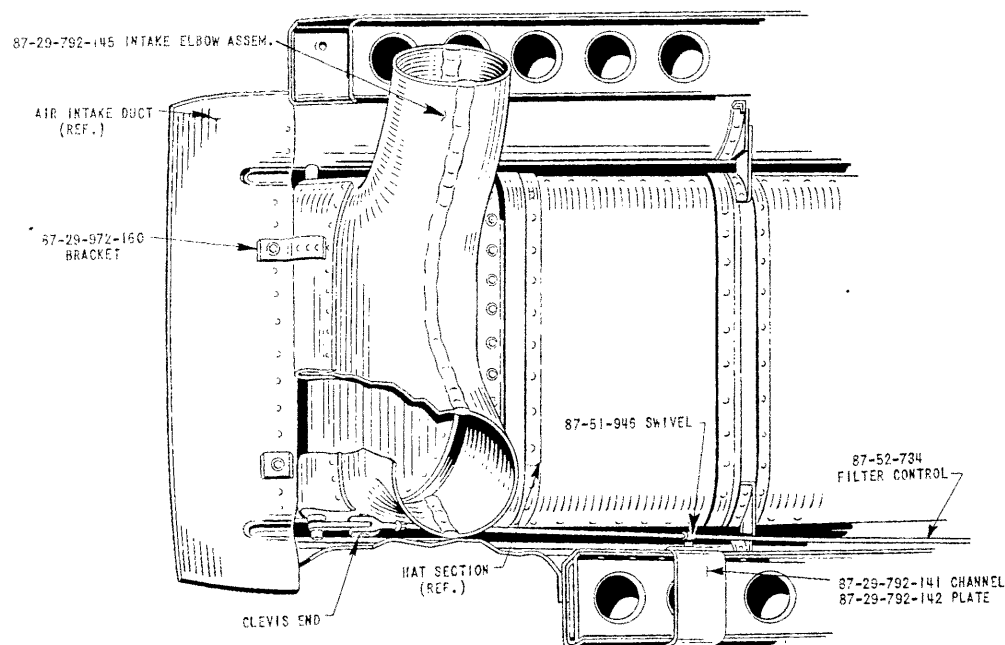
↓ Figure 5 - Air Intake Elbow Installation

(1) Turn the top cowling over and cut bottom section of the carburetor air intake duct between the forward hat section and duct forging. Remove all rivets from the flange and hat section and four rivets on the left- and right-hand side of the forward air intake duct where the bottom part is removed. Enlarge rivet holes with a No. 10 (.193-inch) drill. (See figure 5.)

(2) Place the air filter intake elbow assembly, part No. 87-29-792-145, over the cut-out in the air intake duct and trim aft flange of the air filter elbow assembly to obtain a snug fit between the duct forging and the raised part of the hat section. (See figure 5.)

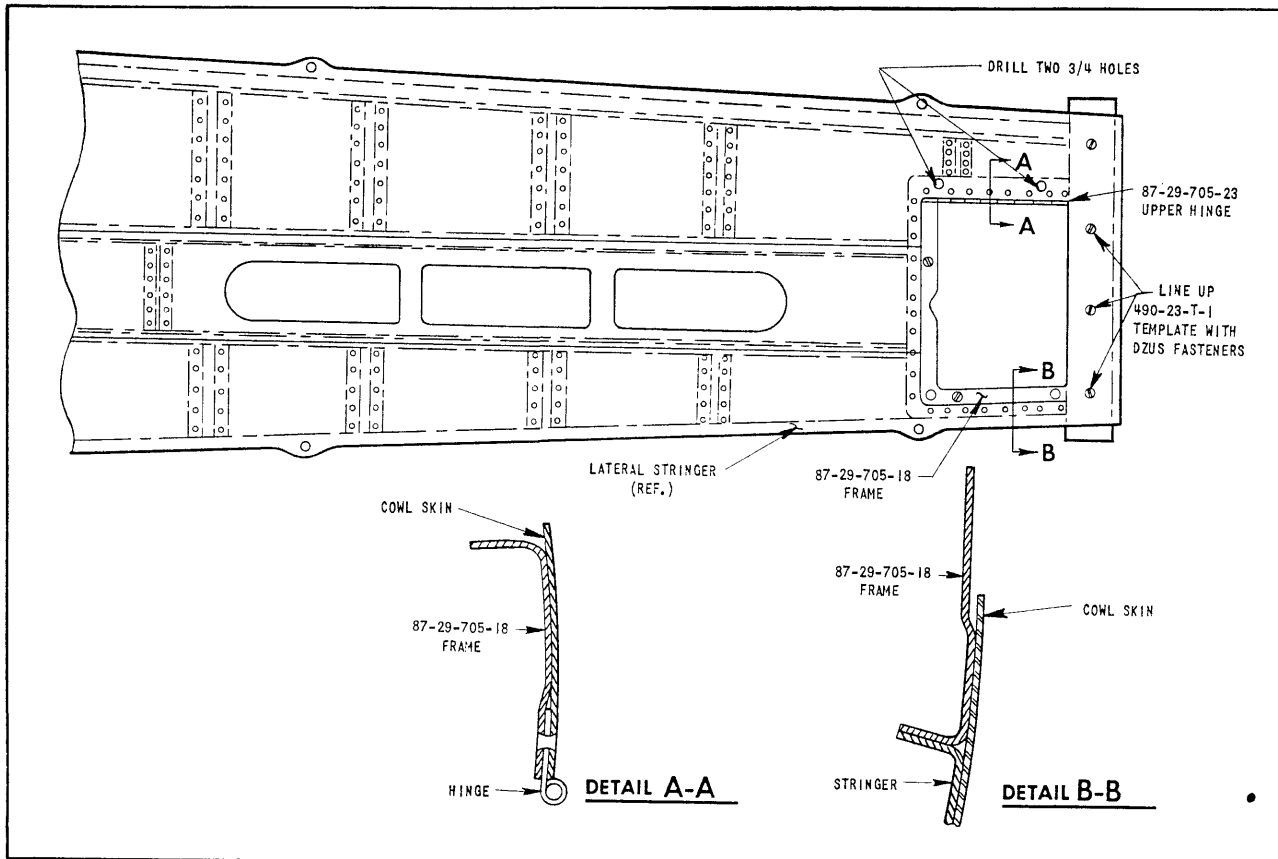
Figure 6 - Air Filter Frame Installation

holes of template, part No. 490-23-T-1, with the three lower Dzus fasteners on the forward end of the side cowling and drill two No. 41 (.0960-inch) holes on the top through the cowling. (See figure 6.)

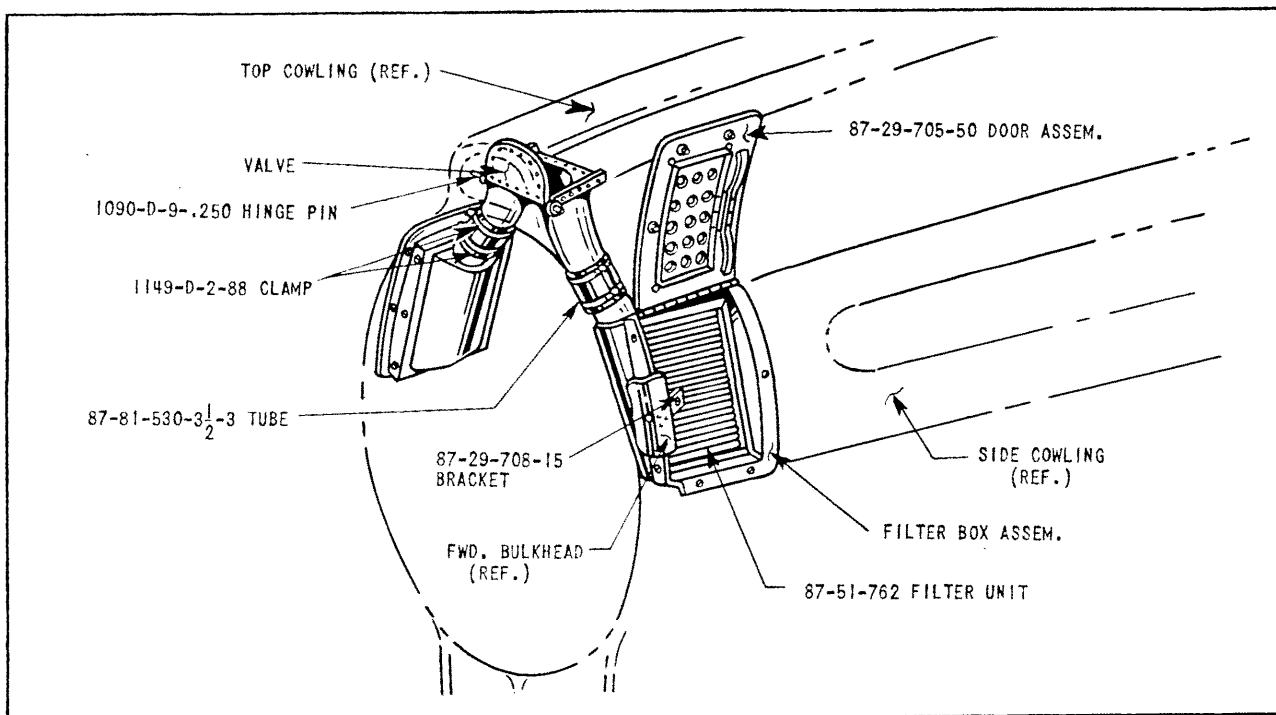
Figure 7 - Installation of Air Filter Assembly

(6) Replace the side cowling to the airplane and lock the filter door. Attach bracket, part No. 87-29-708-15, to the Dzus fasteners on the inside of the door and scribe the four holes to the flange of the forward bulkhead of the airplane. (See figure 7.)

(10) Attach a clamp, part No. 1149-D-2-88, on each of the tubes, part No. 87-81-530-3 1/2-3, and attach tubes to the air filter intake elbow assembly, part No. 87-51-768. (See figure 7.)

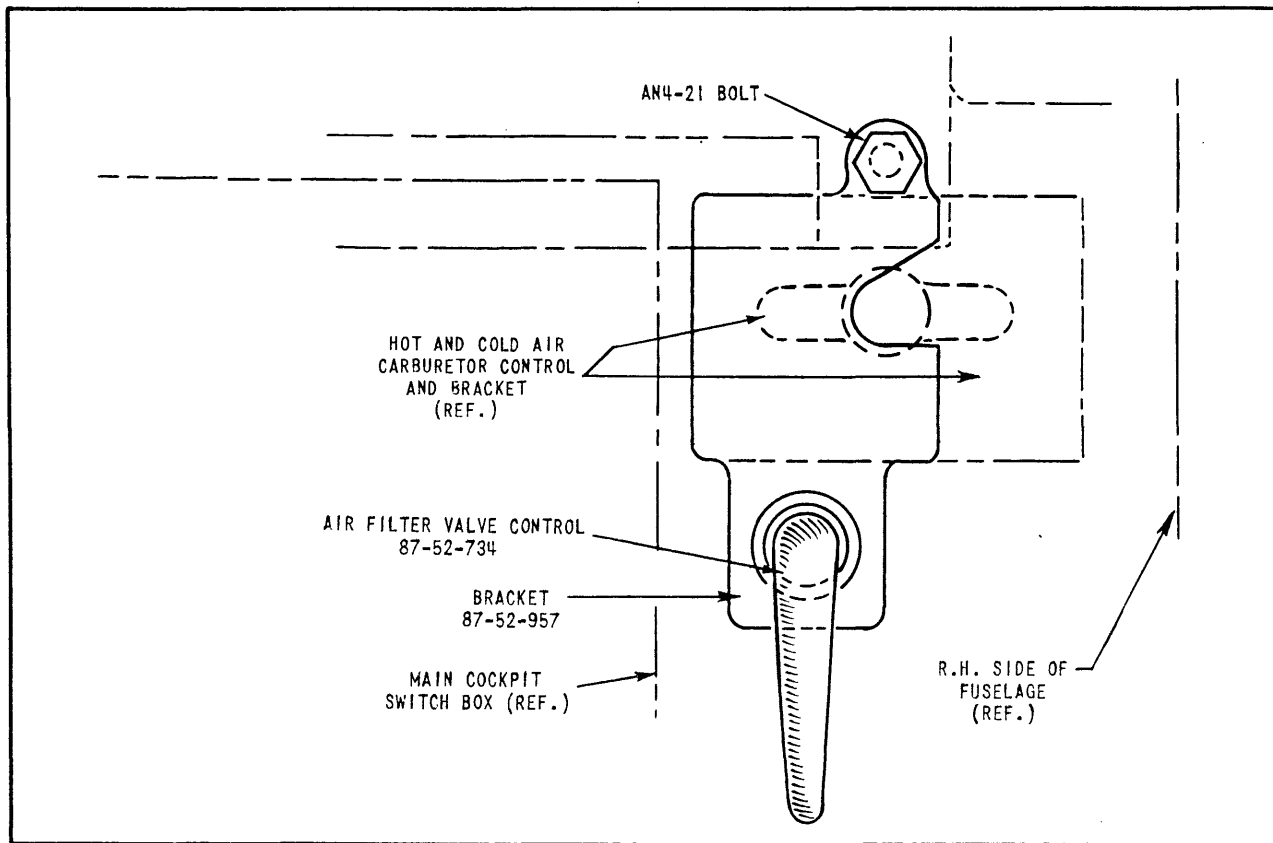
Figure 8 - Installation of Air Filter Control Support Bracket

(1) Remove the 1/4-inch bolt which goes through the rudder pedal support tube directly above the carburetor hot- and cold-air control in the cockpit. Loosen the nut of the carburetor hot- and cold-air control and remove the instruction plate. (See figure 8.)

(2) Install a new filter control support bracket, part No. 87-52-957, and the two halves of the name plate, part No. 87-51-769, such that the holes on the top of the support bracket and the name plate will be fastened to the rudder pedal with bolt, part No. AN4-21. Tighten the new bolt and also tighten the nut on the carburetor hot- and cold-air control. (See figure 8.)

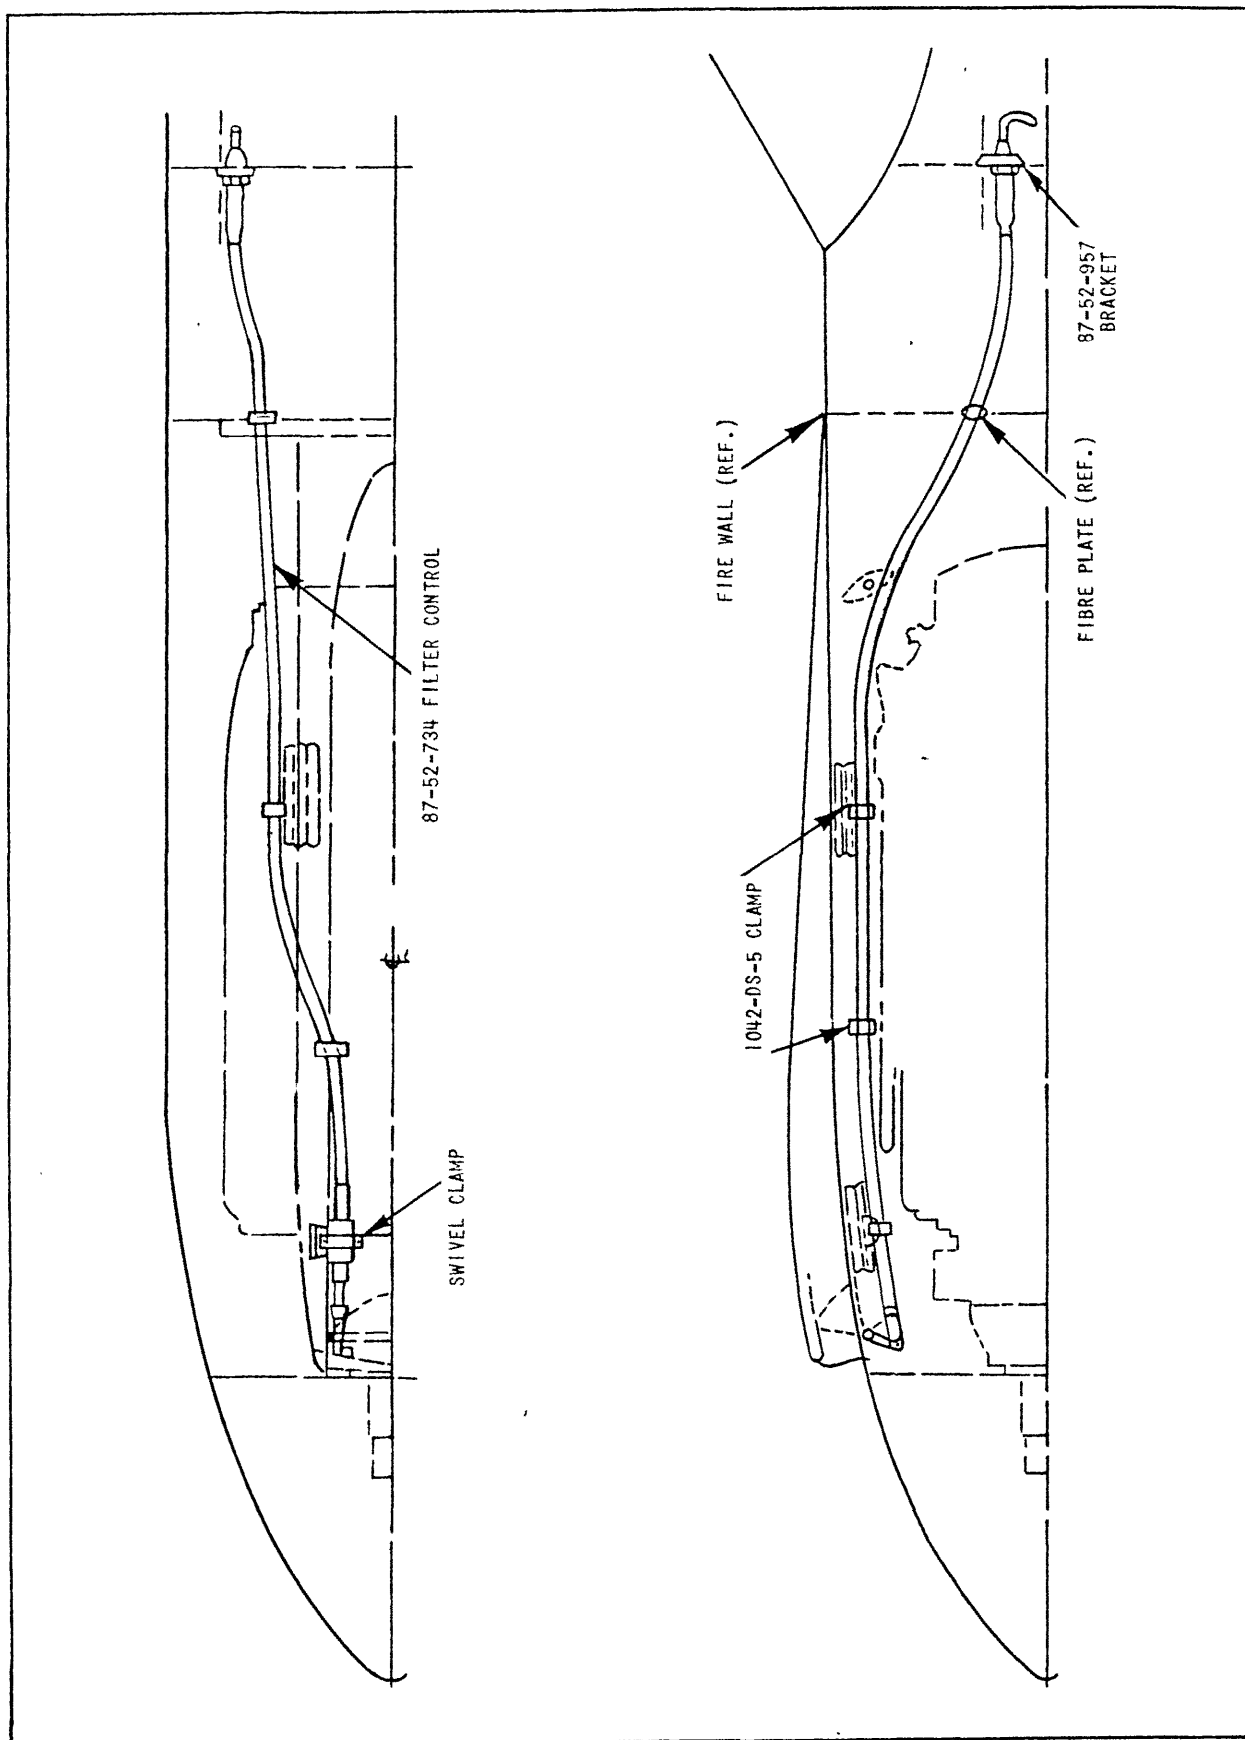
Figure 9 - Installation of Air Filter Control

pit on the right-hand side of the fuselage and through the 3/8-inch diameter hole previously enlarged in the fiber plate at the fire wall. (See figure 9.)

(5) Replace the top cowling on the airplane and route the air filter control, part No. 87-52-734, along the right-hand cowling through the swivel clamp. Attach clevis end to the control and secure clevis end to the arm of the air filter intake elbow assembly, part No. 87-29-792-145, with bolt, part No. AN3-6, nut, part No. AN310-3, three washers, part No. 960-10, and one cotter pin, part No. AN380-2-2. (See figures 5 and 9.)

(6) Secure the air filter control to the screw of the Adel clamp forward of the fire wall which holds the three fuel lines using a clamp, part No. 1042-DS-5, and to the channel of the top cowling where the rivet has been removed, as outlined in paragraph 3.c.(10) with a clamp, part No. 1042-DS-5, screw, part No. 525-1032-7, washer, part No. 960-10, and stop nut, part No. 365-1032. (See figure 9.)

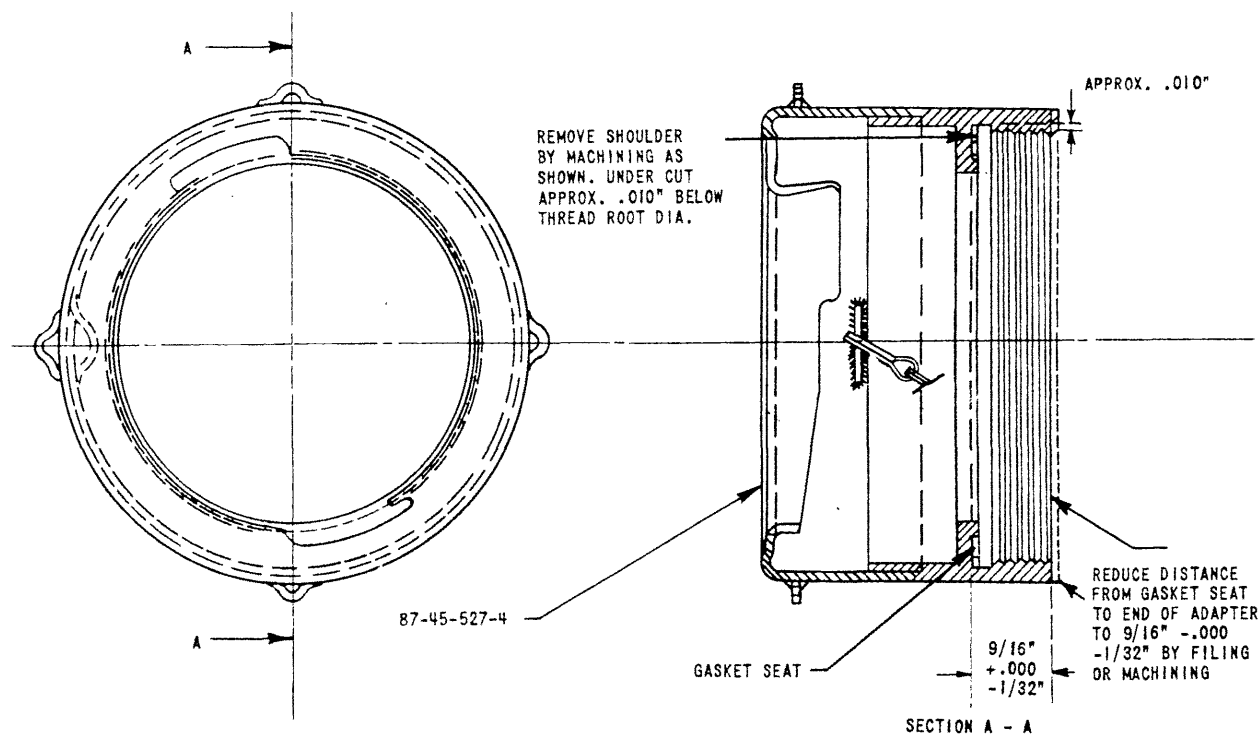
Figure 1 - Modification of Front and Rear Wing Fuel Tank and Filler Cap Adapters

1. To assure a leakproof seal between the adapter and filler neck fitting on both front and rear wing fuel tanks, the filler necks will be reworked on the following airplanes in accordance with the instructions contained in paragraph 2.

*NOTE: The gasket shall be lightly coated with lubricating oil at time of installation. Proper positioning of the gasket can be noted by means of a mirror inserted inside the filler neck illuminated by means of a flashlight.*

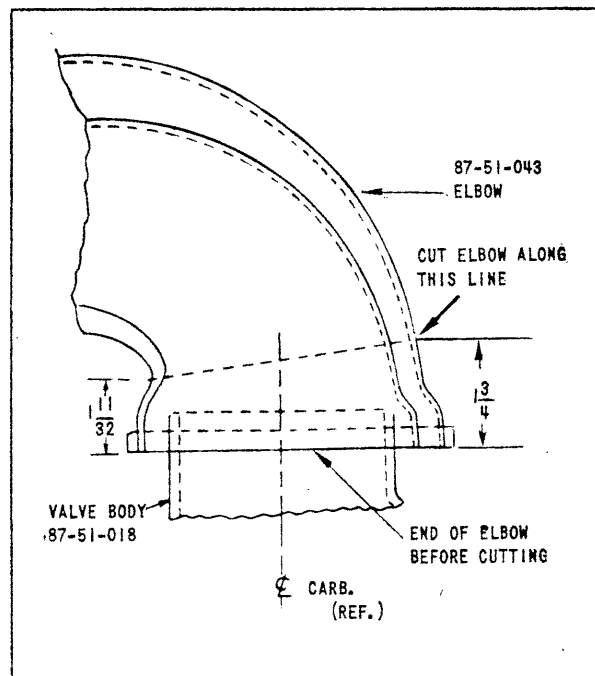
Figure 1 - Carburetor Air Duct Joint

1. To reduce the possibility of air leaking from the carburetor air intake duct due to an imperfect seal between the carburetor and the carburetor air intake duct elbow, the carburetor air intake duct will be modified on all P-40, P-40B, P-40C, and P-40G airplanes in accordance with the instructions contained in paragraph 2.

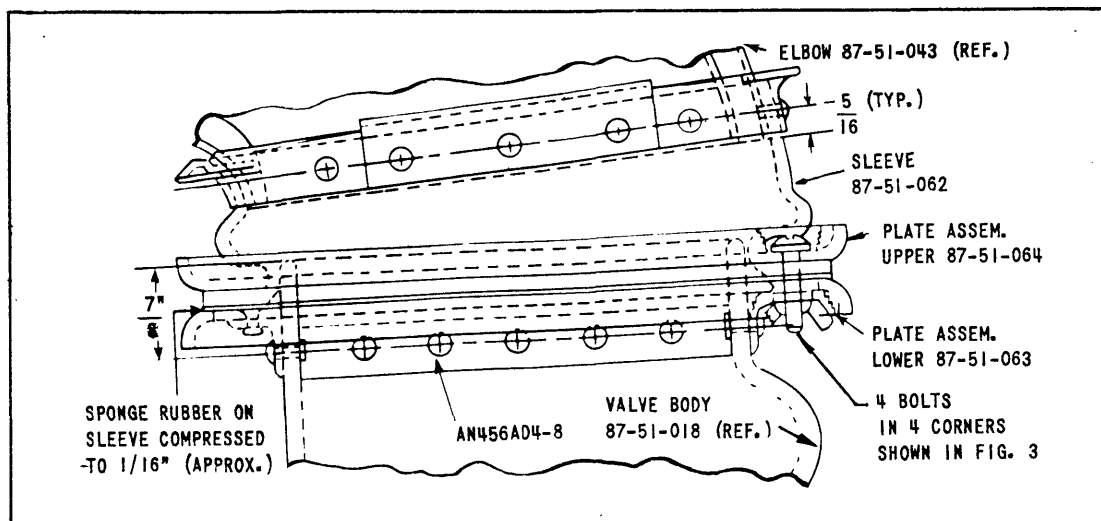
Figure 2 -  
Revised Car-  
buretor Air  
Duct Joint  
Assembly

e. Drill the holes in the reinforcements, part Nos. 87-51-713-1, -2, -3R, -3L, and the neoprene sleeve, part No. 87-51-062, through the elbow, part No. 87-51-043, with No. 30 (.128) drill, as shown in figures 2 and 3.

No. 87-51-018, with No. 30 (.128) drill, as shown in figure 2.

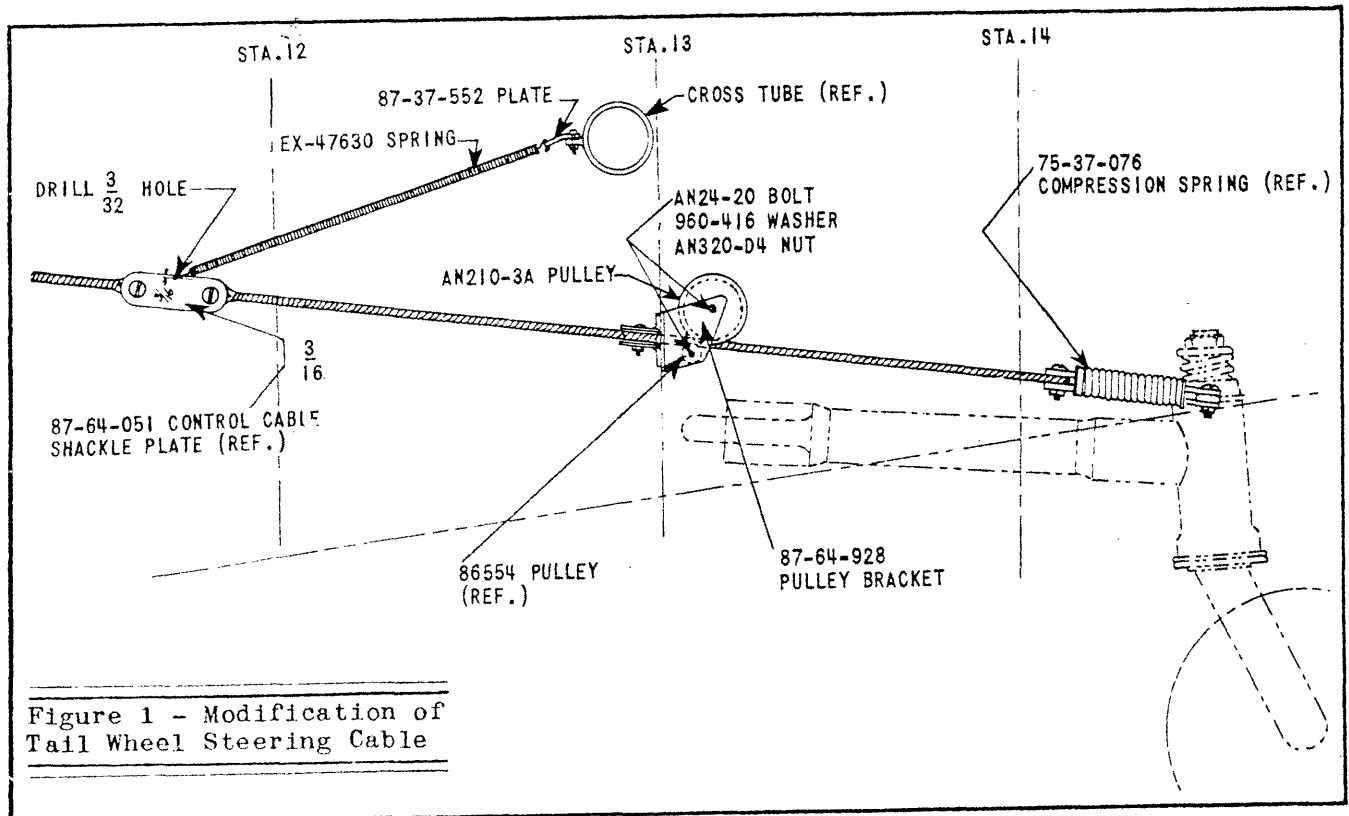
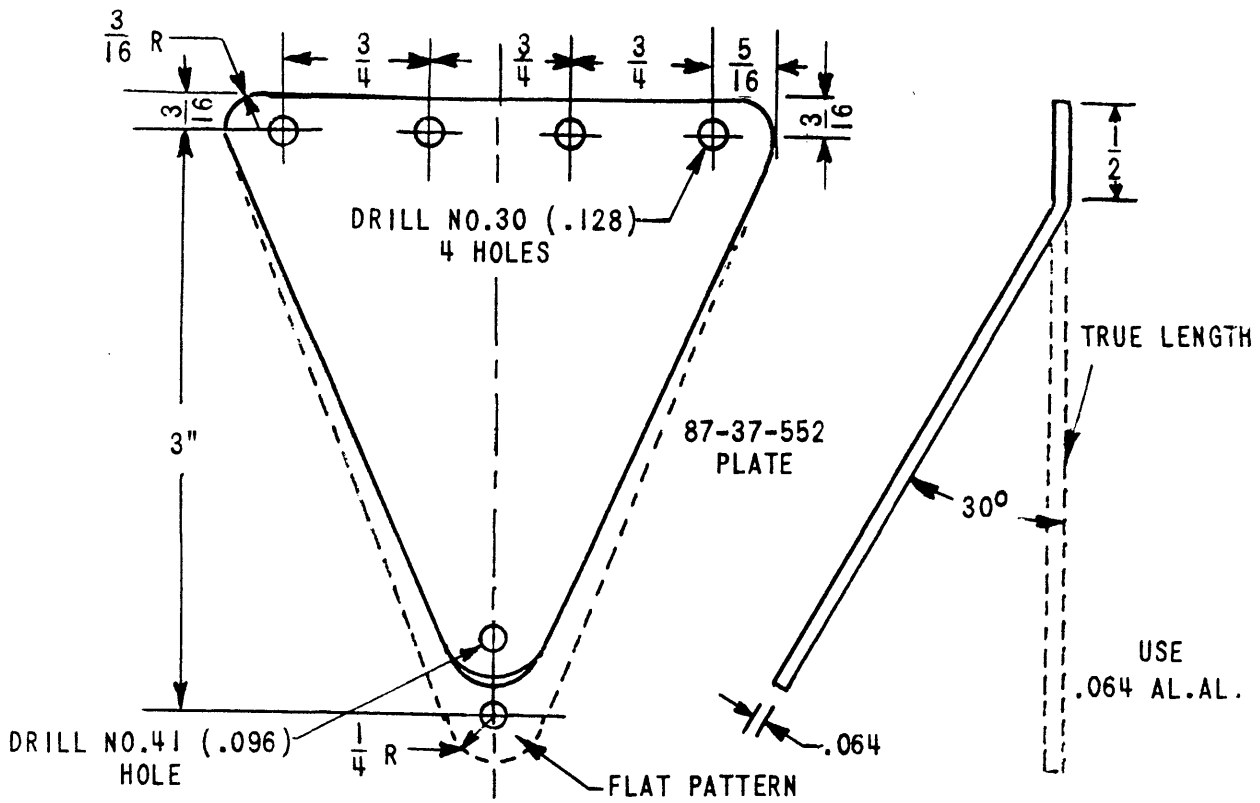
DETAIL (A)

1. To reduce possible damage to the fuselage bulkhead caused by whipping of the tail wheel steering cable during flight, to provide a repair method for fuselage bulkhead in event damage has occurred, and to reduce possible rudder cable failure, the work directed in paragraph 2. will be accomplished on P-40 series airplanes listed below.

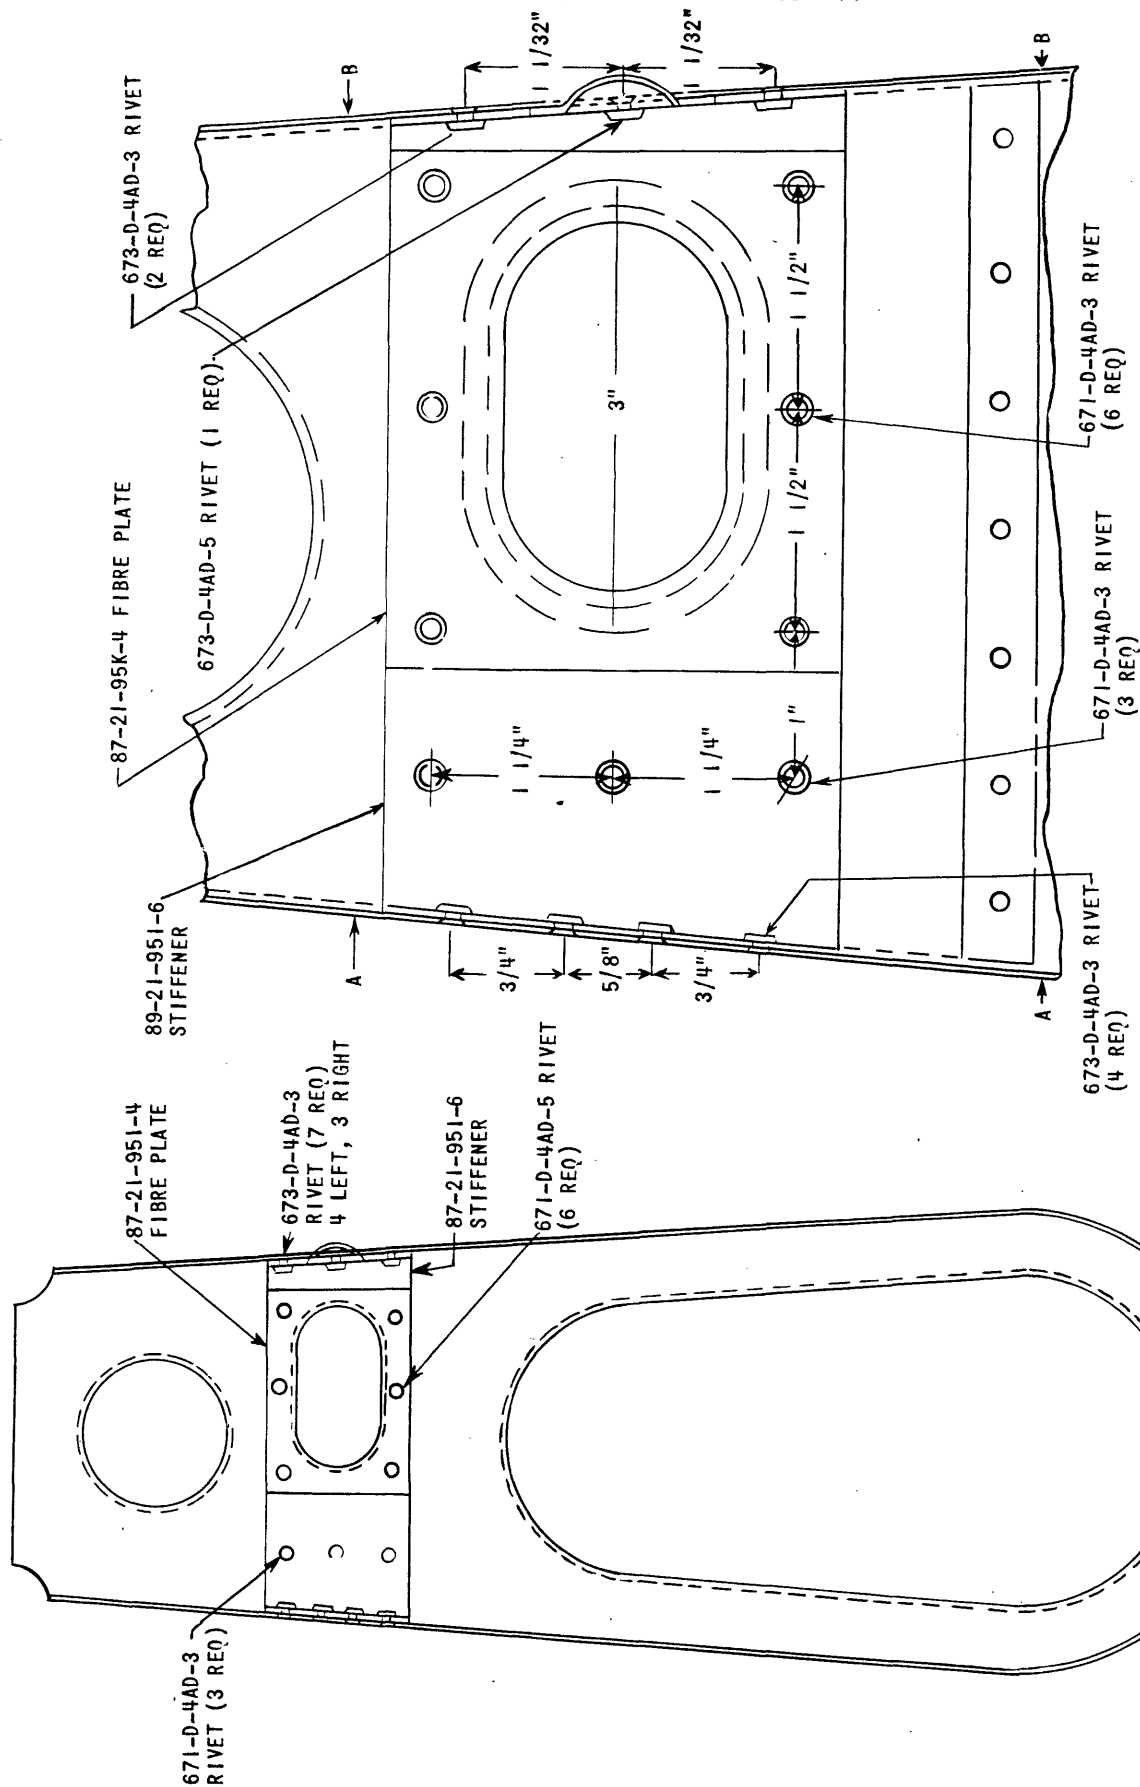
Figure 1 - Station #18 Bulkhead View Looking Forward

1. To reduce the possibility of failure of the rudder trim tab flexible cable at bulkhead station 18, caused by chafing, bulkhead station 18 will be reworked on the following P-40F and P-40K airplanes in accordance with the instructions contained in paragraph 2.

NOTE: If flexible trim tab cable shows signs of wear, tape over the worn section, and shellac over the taped section.

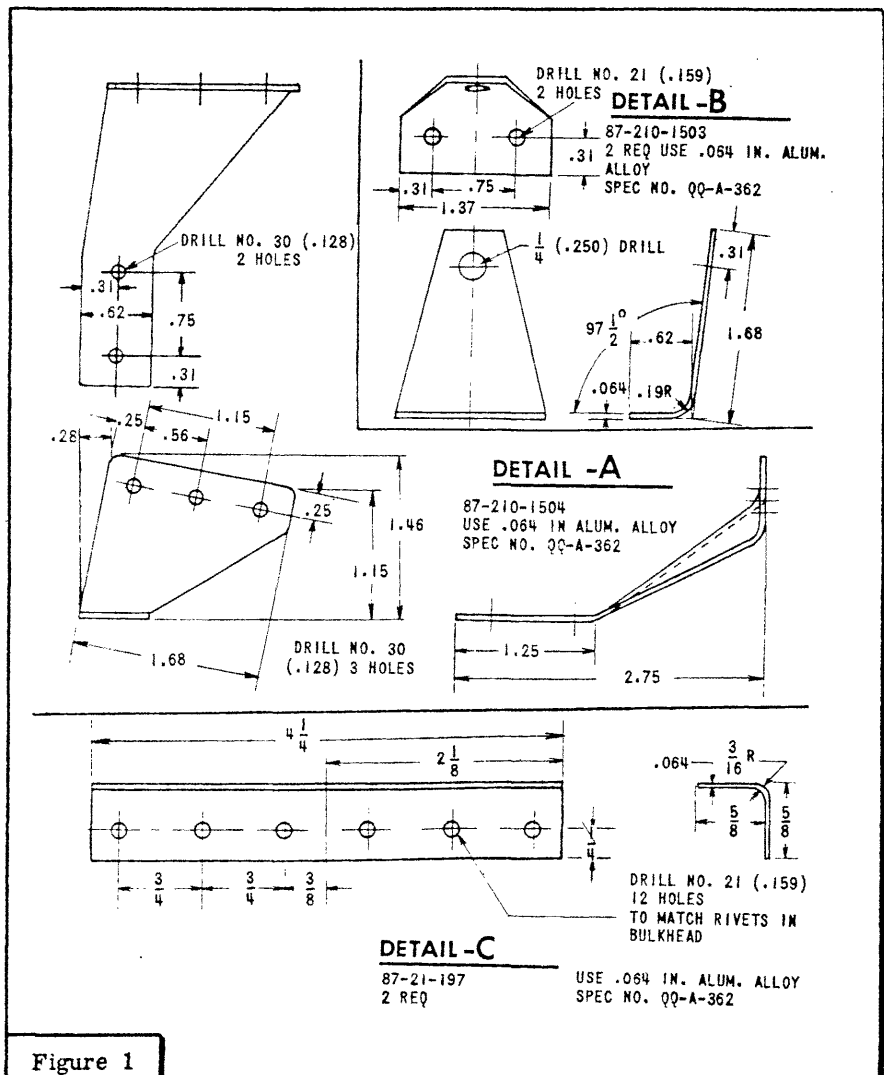
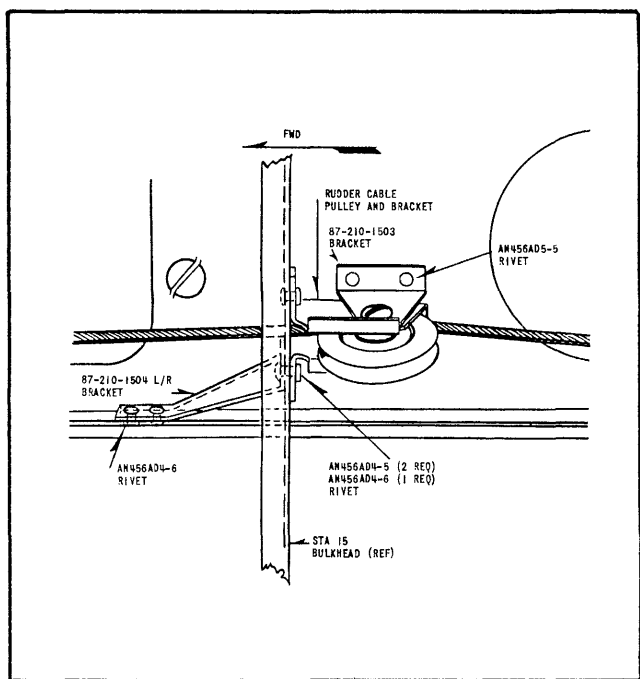
Figure 2 - Reinforcement of the Fuselage  
at Station No. 14 and No. 15 Bulkhead

1. To reduce the possibility of failure due to rudder cable loads, the bulkheads at fuselage stations 14 and 15 on the airplanes listed below will be reworked in accordance with the instructions contained in paragraph 2.

d. Install bracket, part No. 87-210-1503, on top of the pulley bracket in such a manner that the 1/4-inch hole in the bracket will match the hole in the pulley bracket with the new bracket, part No. 87-210-1503, attached. (See figure 2.)

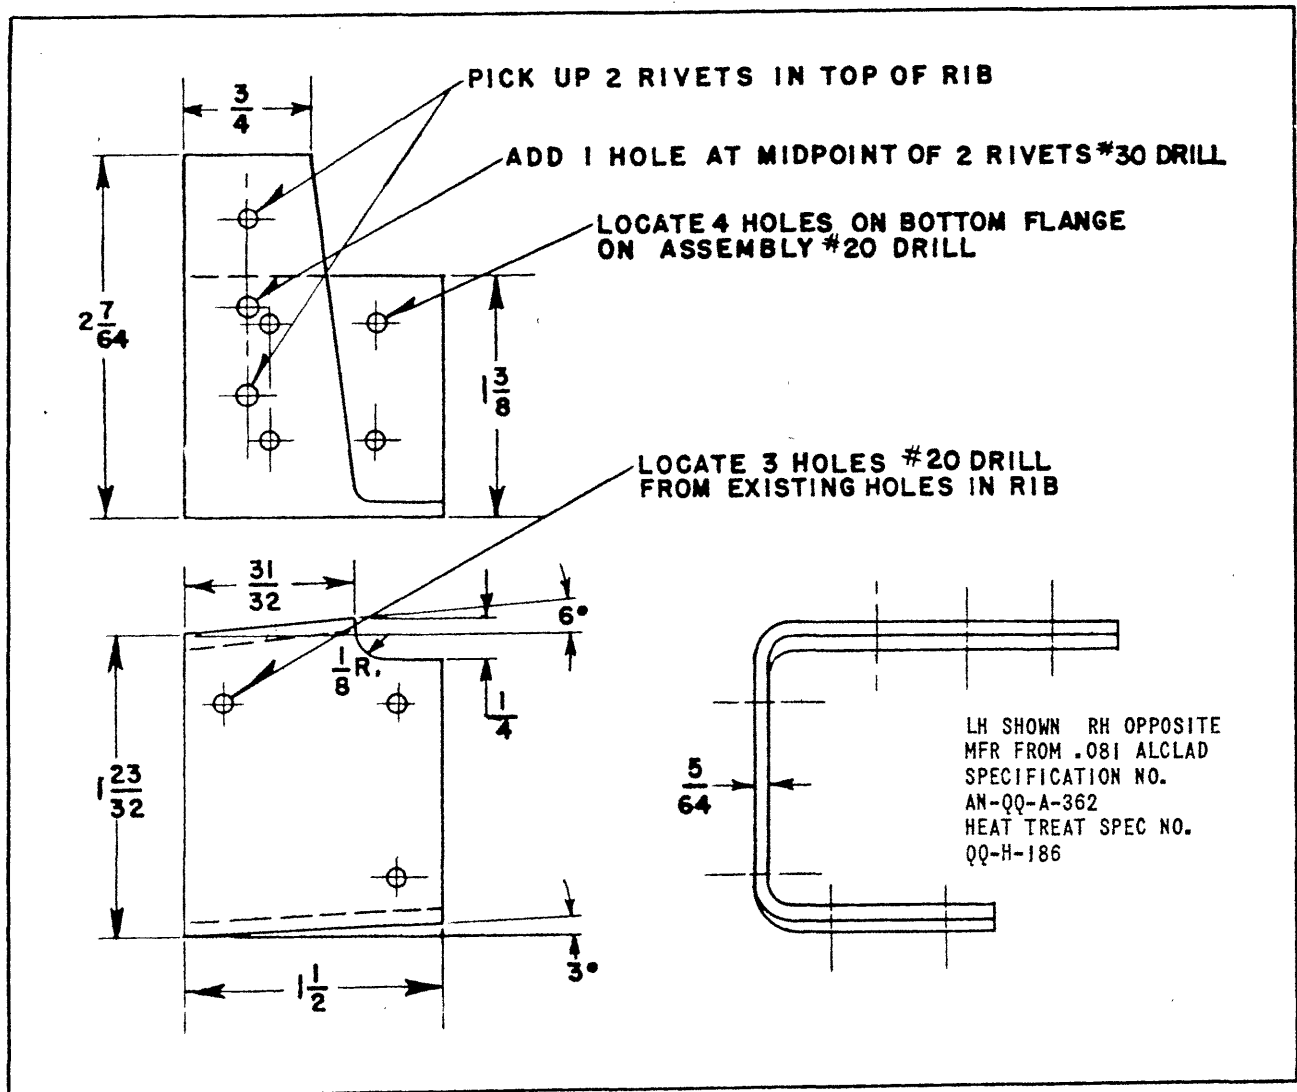
Figure 2 - Aileron Outboard End Gusset, Part No. SK9104

1. To decrease possibility of failure of aileron end rib, the RP-40D, P-40E, P-40E-1, P-40F, P-40K, P-40K-1, P-40L, P-40M, P-40N, P-40R-1, and P-40R-2 airplanes will be reworked in accordance with the instructions contained in paragraph 2. P-40N airplane, AF No. 43-24252 and subsequent, will be modified by the contractor prior to delivery.

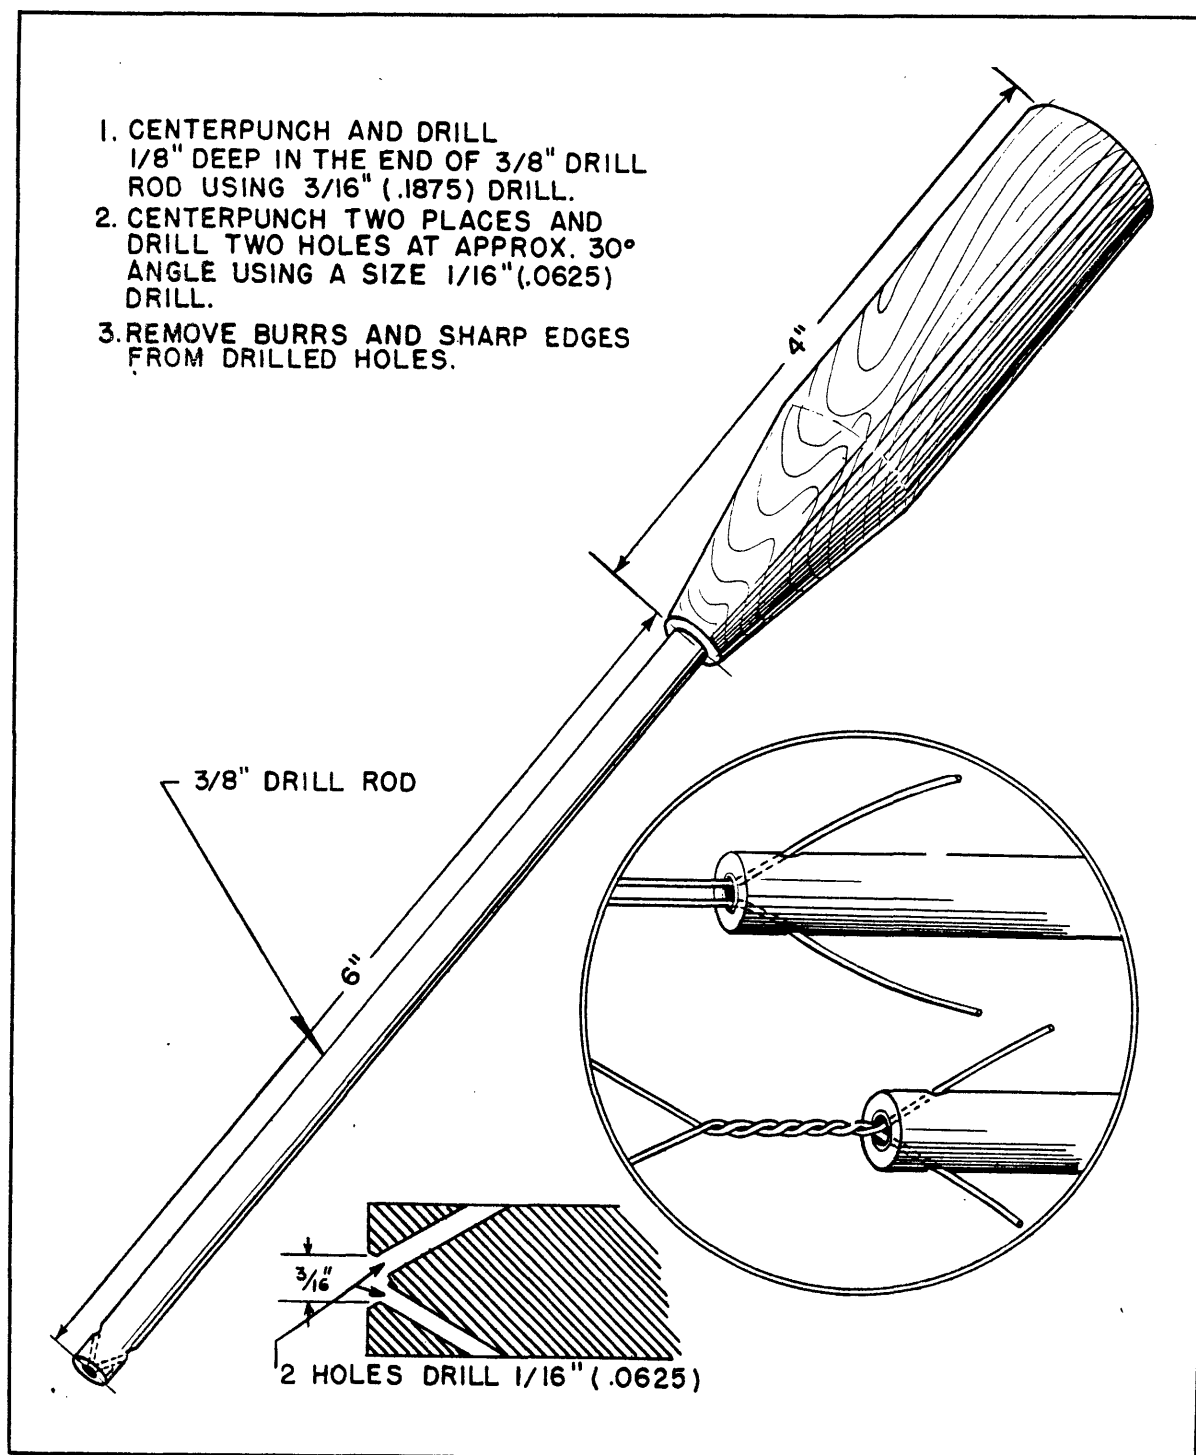
Figure 6 - Tool for Installing Safety Wire While Canopy Is on Airplane

m. In all investigated cases of canopy failure, the fact has been well established that self-jettisoning was accomplished. This can only be caused by improper safety wiring or loose fitting canopies becoming unlocked through the buffeting vibration or high loadings.
