CURTISS P-40  
BULLETINS

**ESSCO INC.**  
426 WEST TURKEYFOOT LAKE RD.  
AKRON OH 44319  
330-644-7724/FAX 330-644-0886

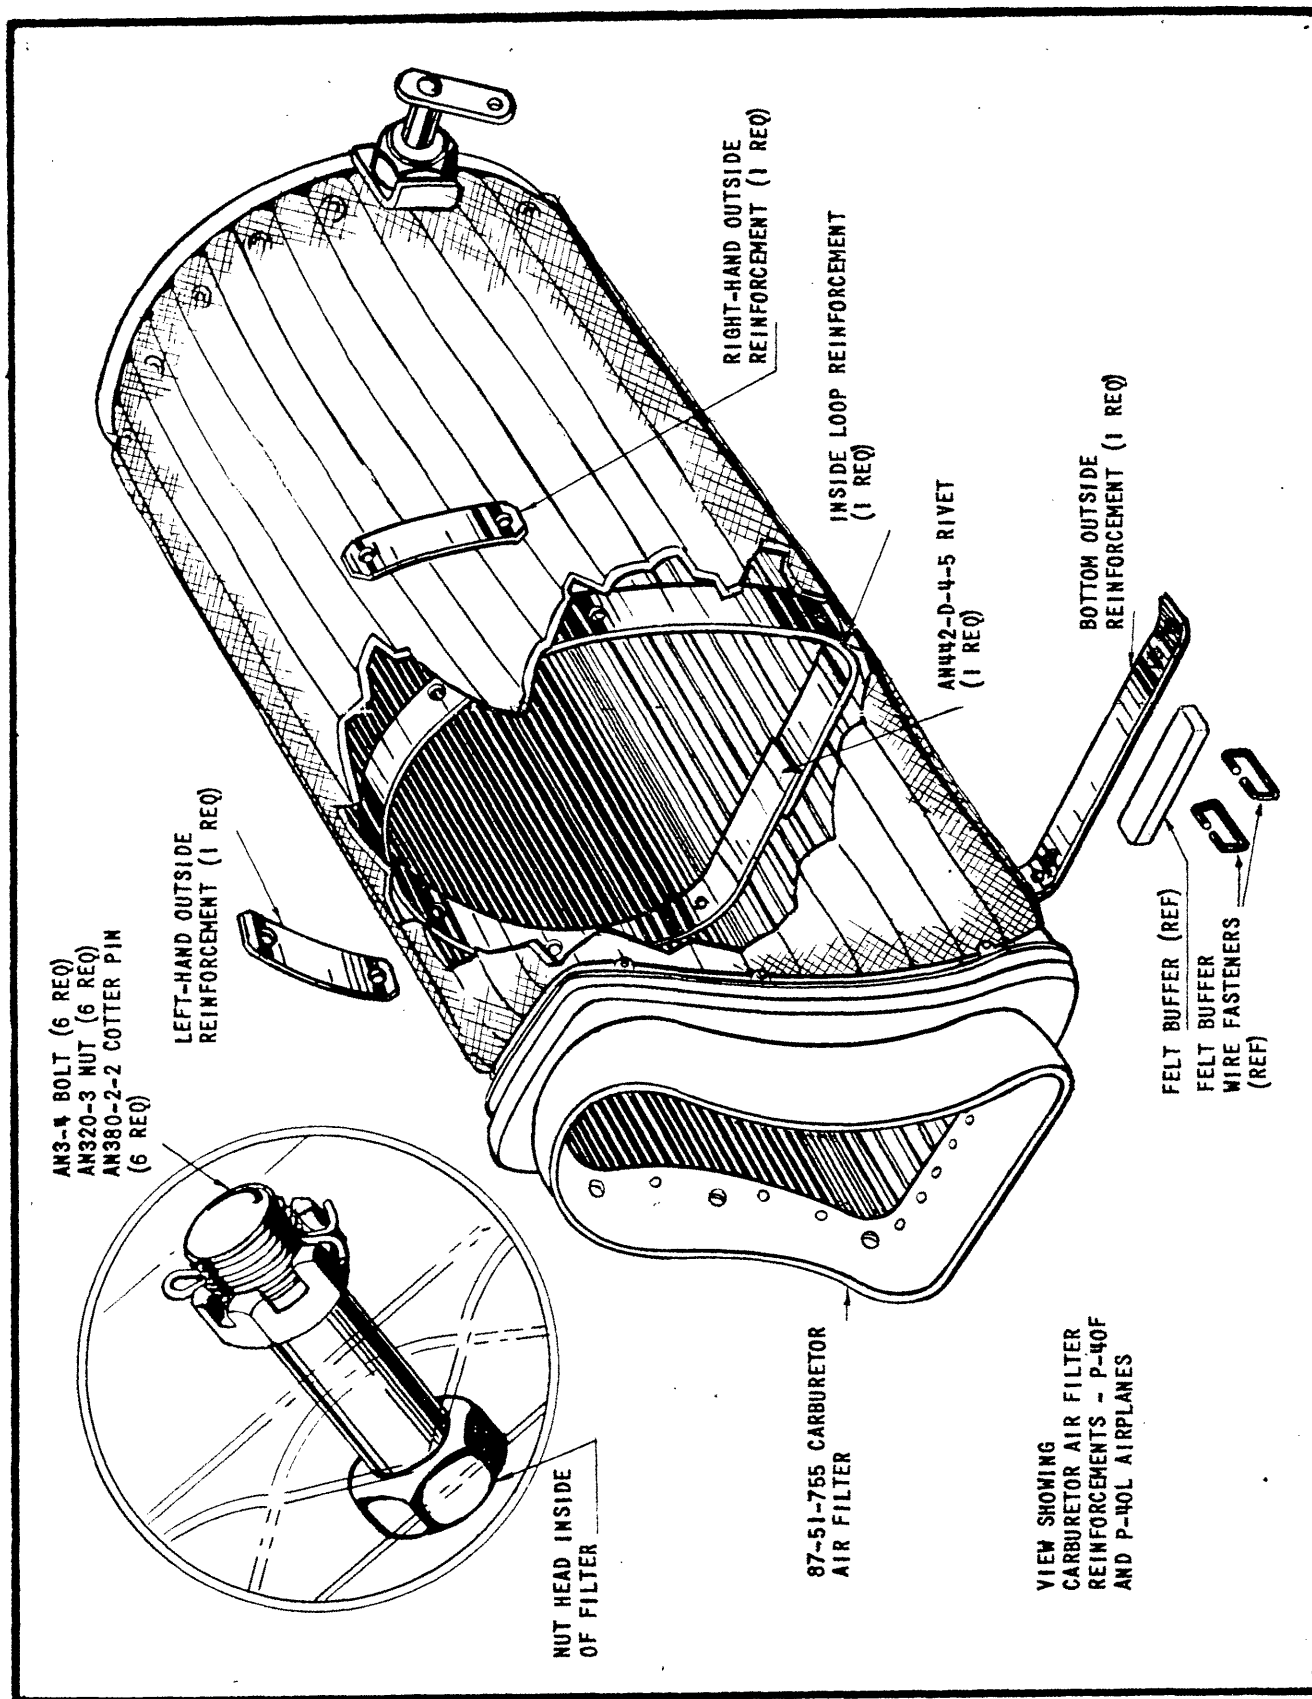
Figure 2 - View Showing Carburetor Air Filter Reinforcements

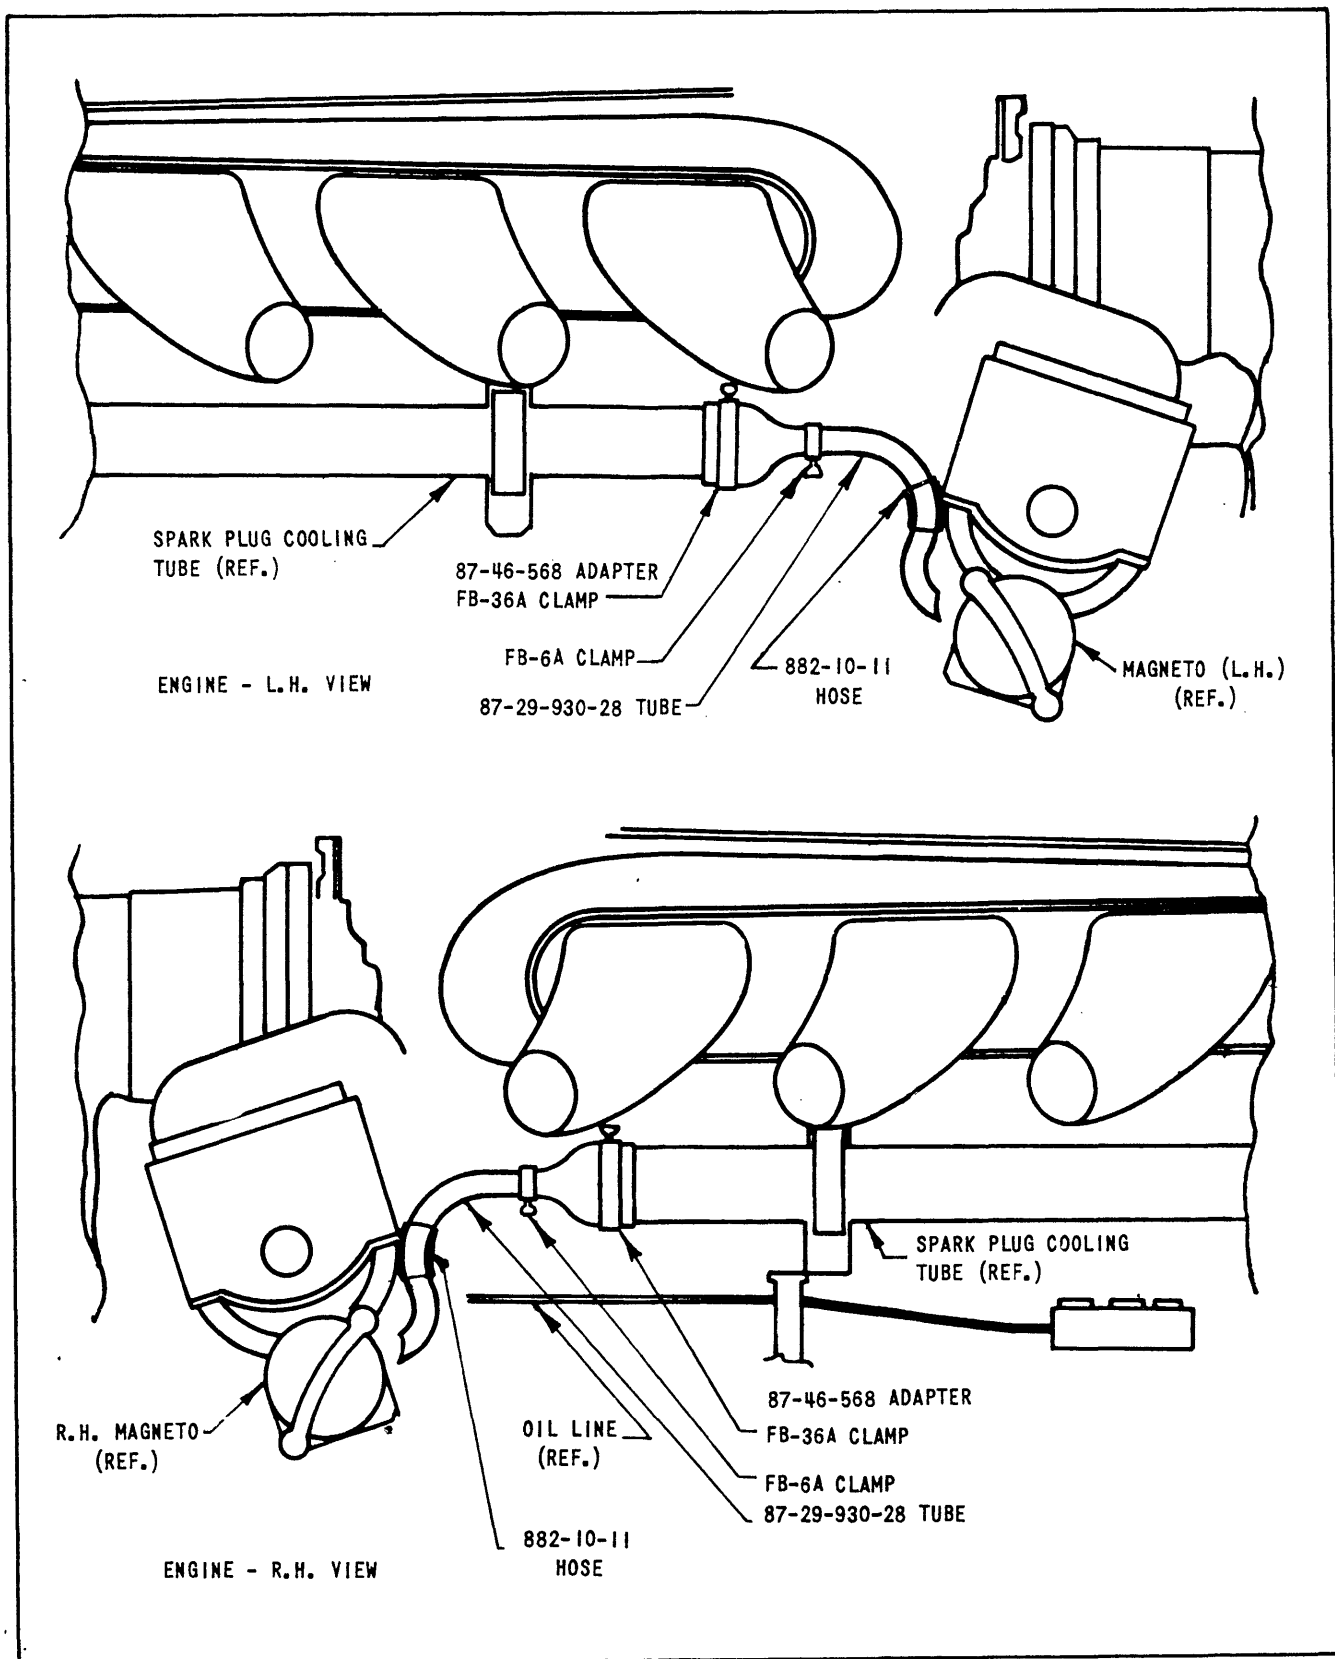
Figure 1 - Installation of Magneto Cooler Tubes

a. All P-40F and P-40L airplanes will be inspected to see if the position of air blast tube has been changed from the breaker housing to the correct position noted herein.

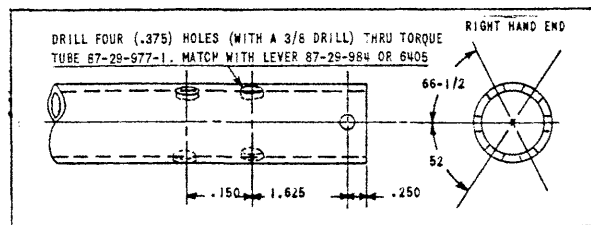
Figure 1 - Rework of Cowl Flap Control Torque Tube 87-29-917

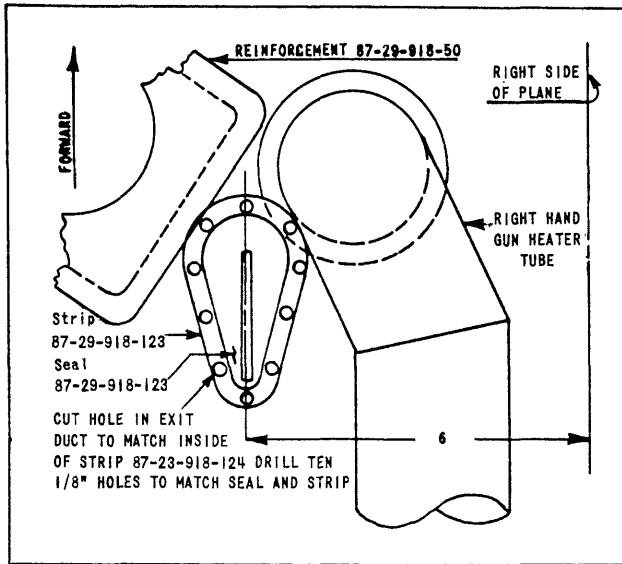
Figure 2 - Rework of Exit Duct 87-29-918 to Install Seal 87-29-918-123

i. Remove the screw jack seal and seal frame from the left-hand side of the exit duct. Place a patch, part No. 87-

29-918-901, over the hole in the exit duct and drill eight No. 30 (.128) holes in the exit duct to match the patch. Rivet the patch to the exit duct with eight rivets, part No. 671-D4-AD-4.

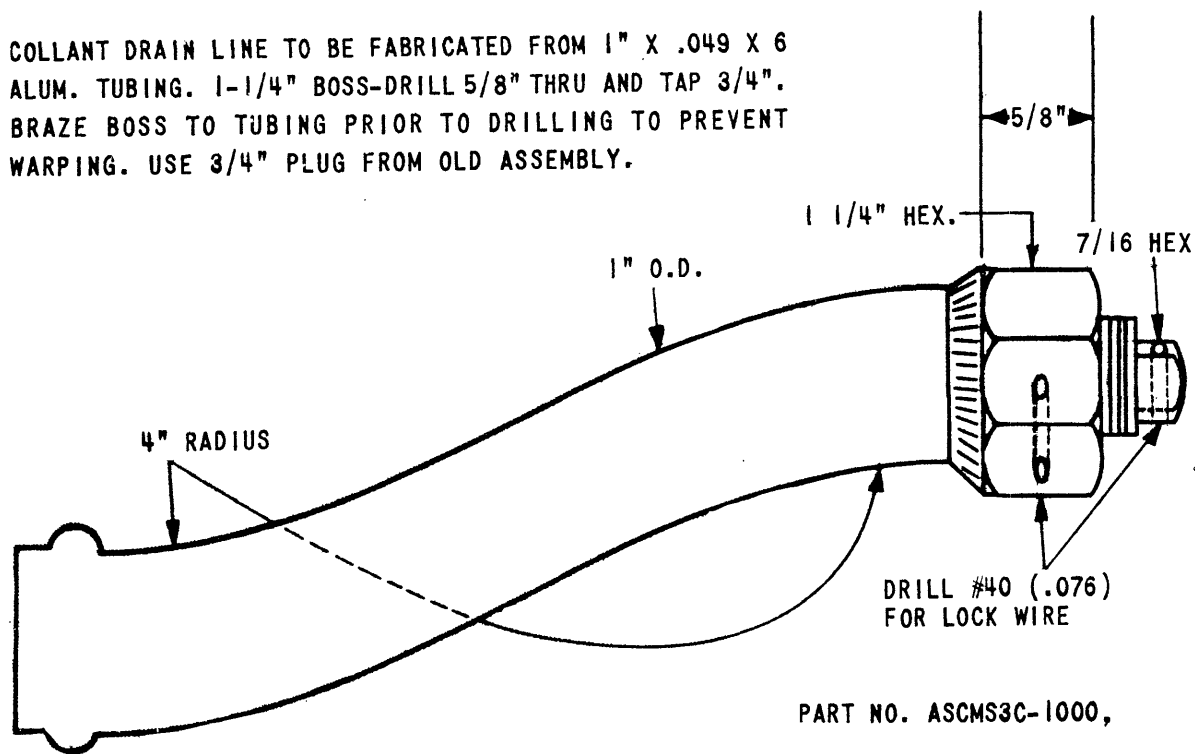
1. To prevent chafing, the coolant drain lines, part Nos. 87-50-068-14, 87-50-068-12, and 87-50-068-13, installed in P-40F and P-40L airplanes will be replaced in accordance with the instructions contained in paragraph 2.

Figure 1 - Fabrication of Coolant Drain Line, Part No. ASCMS3C-1000

COLLANT DRAIN LINE TO BE FABRICATED FROM 1" X .049 X 6 ALUM. TUBING. 1-1/4" BOSS-DRILL 5/8" THRU AND TAP 3/4". BRAZE BOSS TO TUBING PRIOR TO DRILLING TO PREVENT WARPING. USE 3/4" PLUG FROM OLD ASSEMBLY.

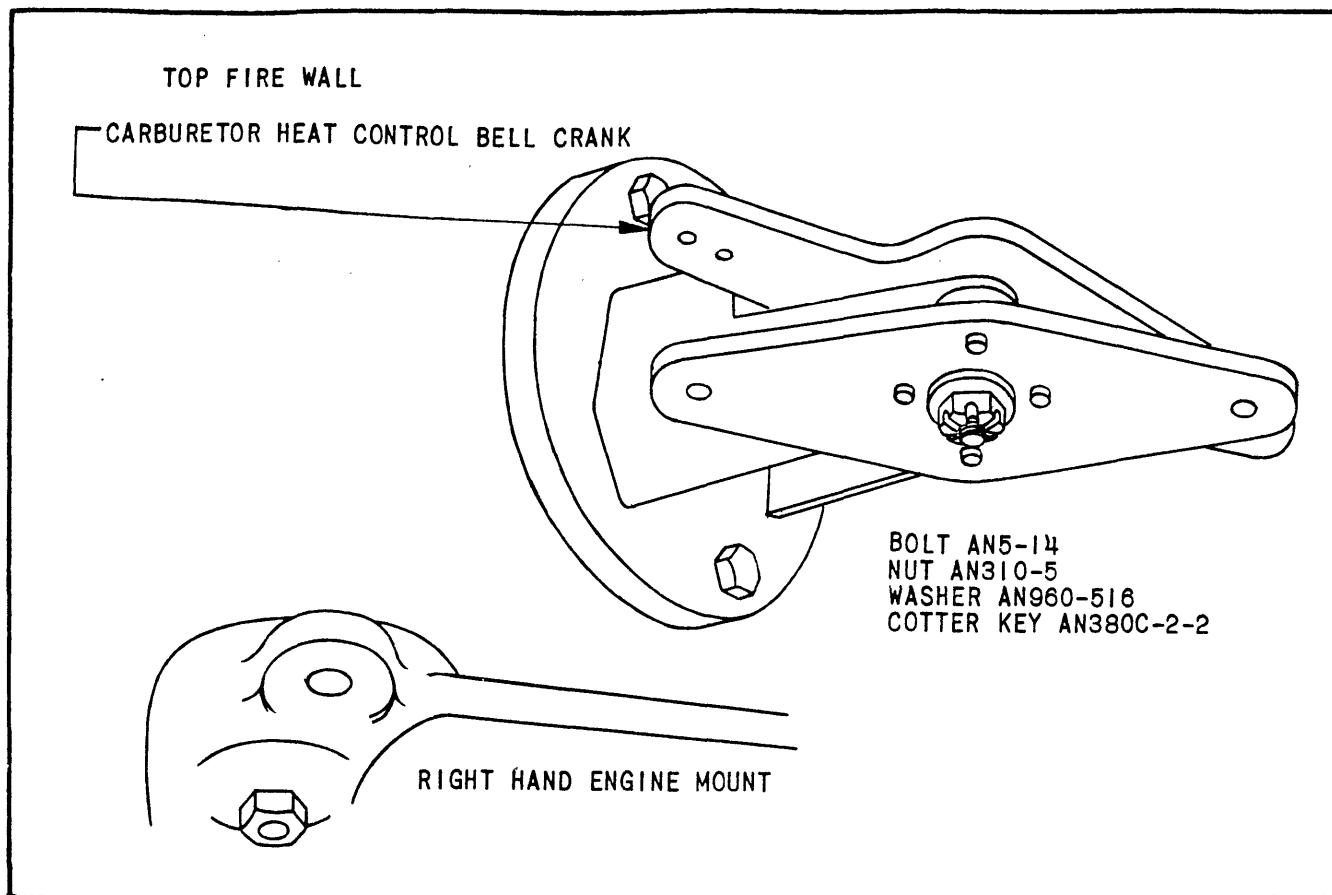
1. To prevent possible failure of the carburetor heat control linkage due to insufficient strength of the existing bell crank, part No. 87-52-547, at fuselage station No. 1, a newly designed type bell crank, part No. 87-460-1039, will be installed on the airplanes listed below in accordance with the instructions contained in paragraph 2.

Figure 1 - Bell Crank at Fuselage Station No. 1

d. Replace original bell crank, part No. 87-52-547, with new bell crank, part No. 87-460-1039, on the left.

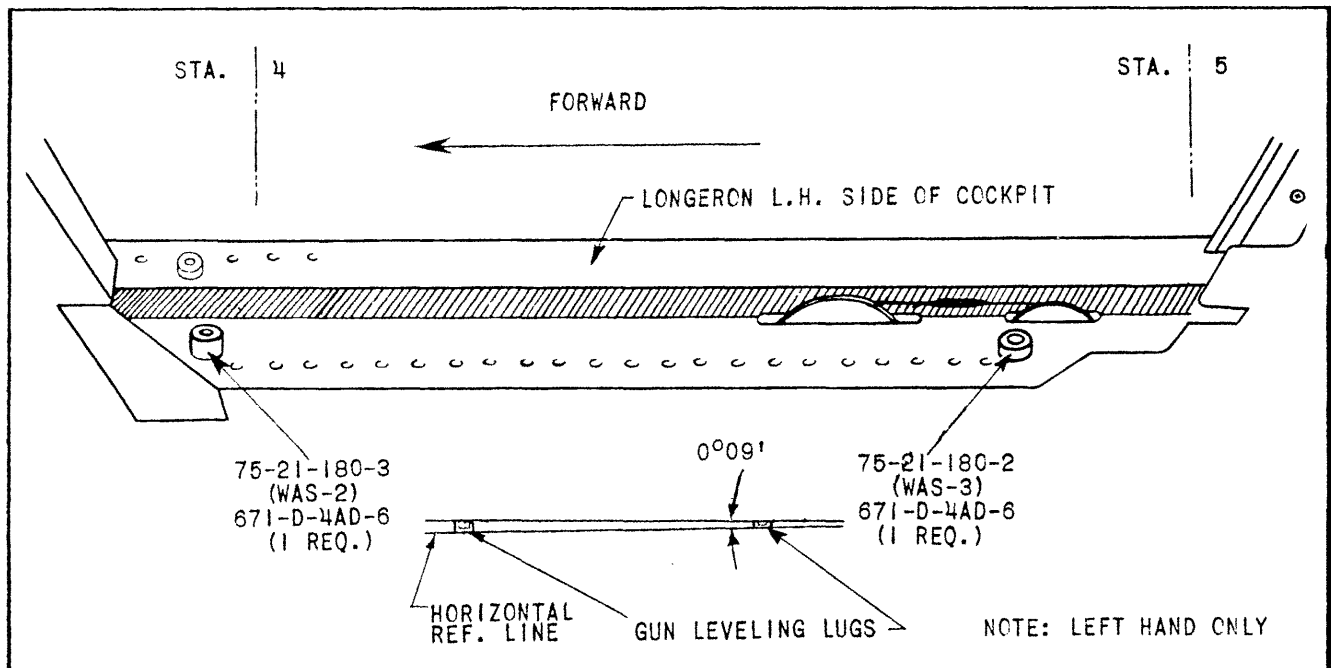
Figure 1

1. The gun leveling lugs on certain P-40N airplanes have been found to be installed incorrectly. The use of these lugs in the present position results in improper harmonization of the guns. To correct this condition the gun level lugs on P-40N airplanes, AF serial Nos. 42-104429 to 42-104575 inclusive, will be changed in accordance with the instructions contained in paragraph 2. P-40N airplane, AF No. 42-104576 and subsequent, will have this modification accomplished prior to delivery.

b. Reinstall the gun leveling lugs by reversing their positions so that the

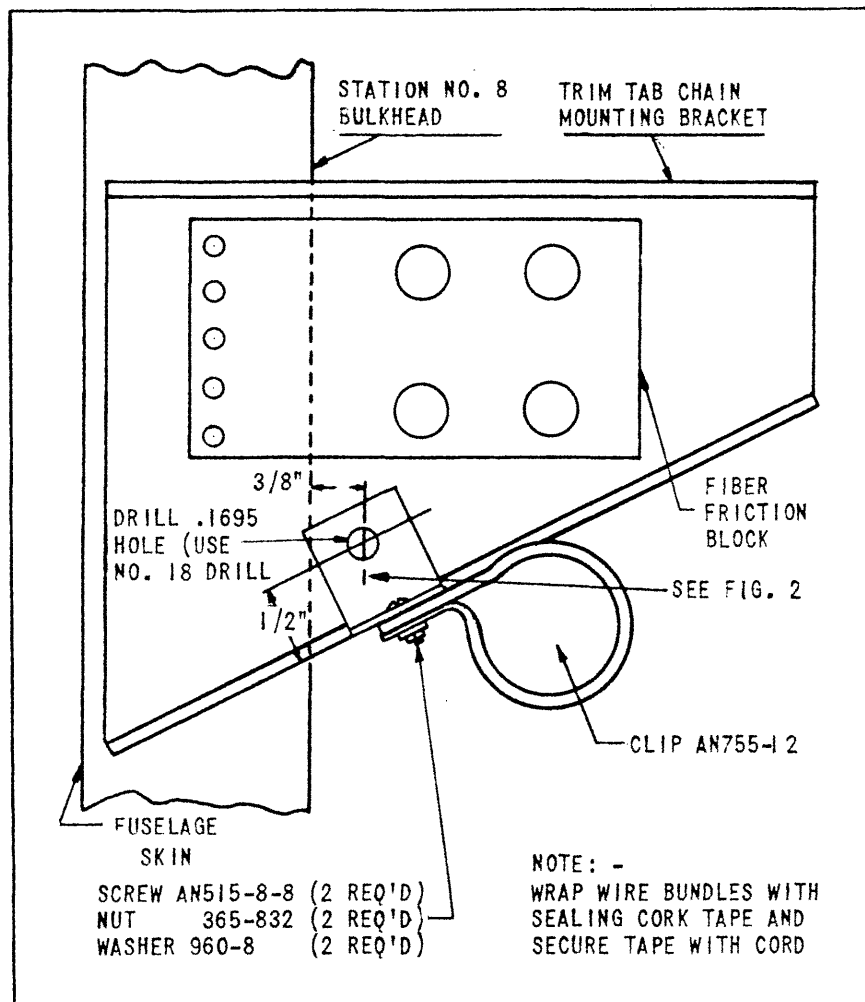
1. To prevent electrical failure caused by the control cables cutting into wire bundles along the left side of the fuselage from stations 6 to 9 inclusive, the following P-40N airplanes will be reworked in accordance with instructions in paragraph 2.

Figure 1 - Relocation Of Wire Bundles To Trim Tab Bracket At Fuselage Station 8

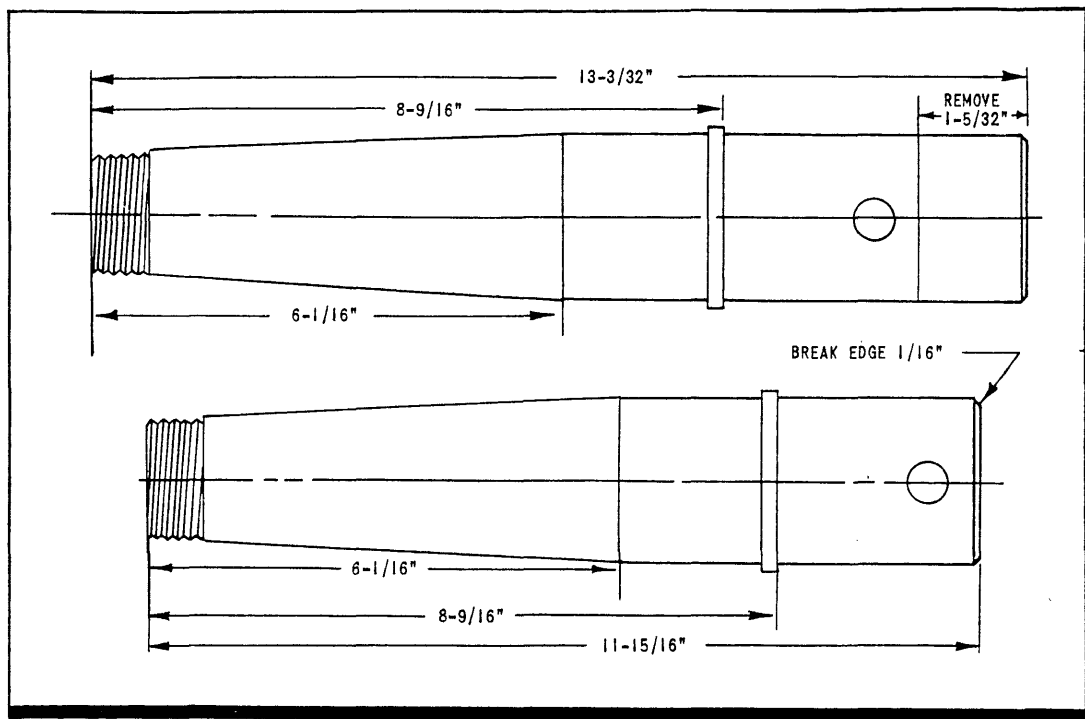
1. To reduce the possibility of failure, the left- and right-hand main landing-gear axle fittings, part No. 87-310-1014 (open heel), on the P-40N airplanes listed below will be removed and replaced with a stronger axle fitting, part No. 87-310-1021 (solid heel), in accordance with the instructions contained in paragraph 2. If the parts necessary for this work are not available, a preflight inspection of the axle fitting will continue to be accomplished and if tolerance between axle and axle fitting on inboard side of landing gear exceeds .015 inch with the weight of the airplane on the wheels, the airplane will be grounded until the modification outlined in this Technical Order is accomplished. Upon completion of this rework the above prescribed preflight inspection will no longer be required.

Figure 1 -  
Detail View Show-  
ing Modification  
of Axle, Part No.  
87-310-1015

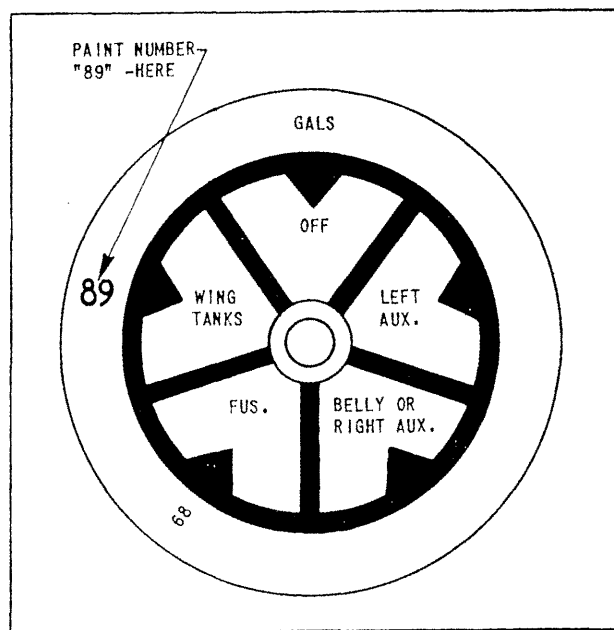
1. To indicate the proper wing tank gallonage, the fuel selector valve dials on the P-40N airplanes listed below which have had the front (35 gallons) and rear wing tanks (54 gallons) interconnected, will be reworked in accordance with the instructions contained in paragraph 2.

Figure 1 - Reworked Fuel Tank Selector Valve Dial

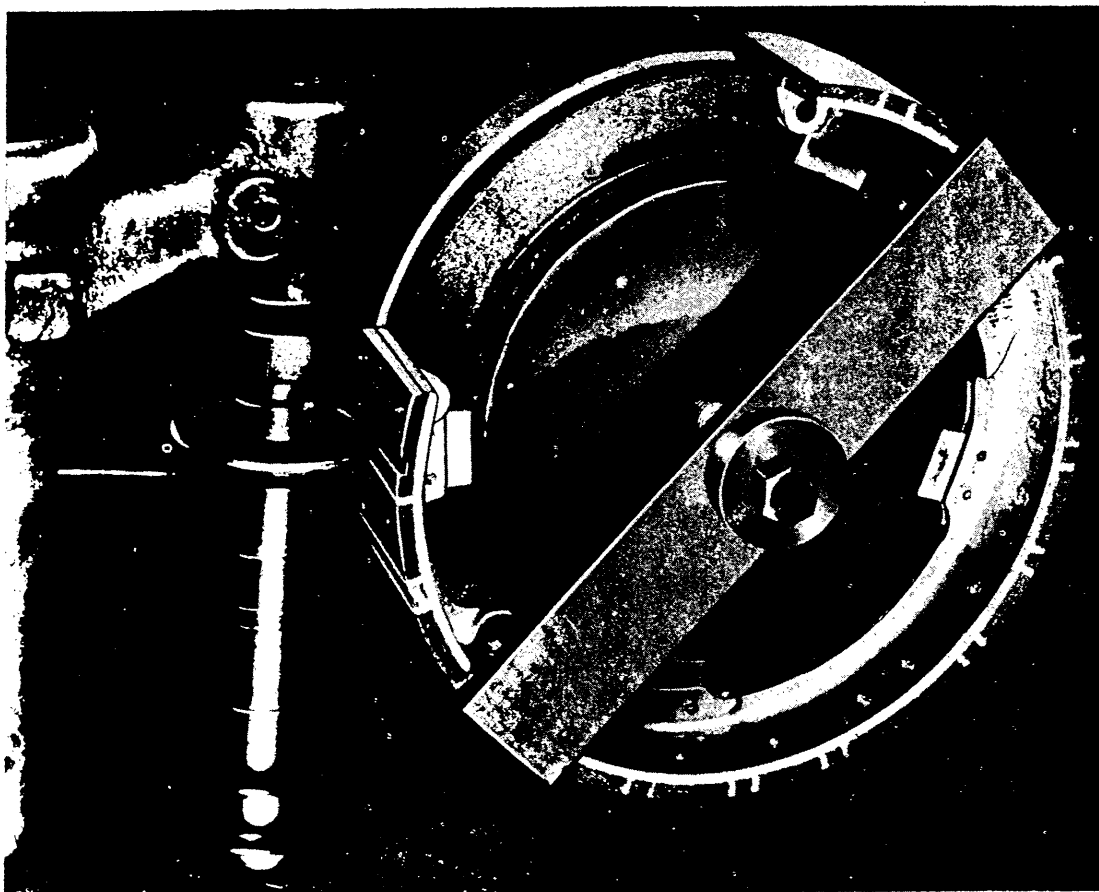
Figure 4 - Grooving the Brake Lining

- Remove the wheels from the airplane.
- Remove the brake shoes from the torque plates.
- Mark each lining with chalk or white pencil  $\frac{7}{16}$  inch on each side and parallel with the rivet holes. (See figure 1.)
- Mount the brake shoe on a milling machine using set-up and accessories similar to those shown in figures 2, 3, 4, and 5.
- Align the chalk or pencil mark with the approximate center of the  $\frac{3}{16}$ -inch milling cutter, clamp the brake shoe firmly in place and cut the groove across the lining. (See figure 4.)

**CAUTION** When setting the depth of the cut, allow  $\frac{1}{8}$  inch of lining to remain between the bottom of the groove and the metal brake shoe.

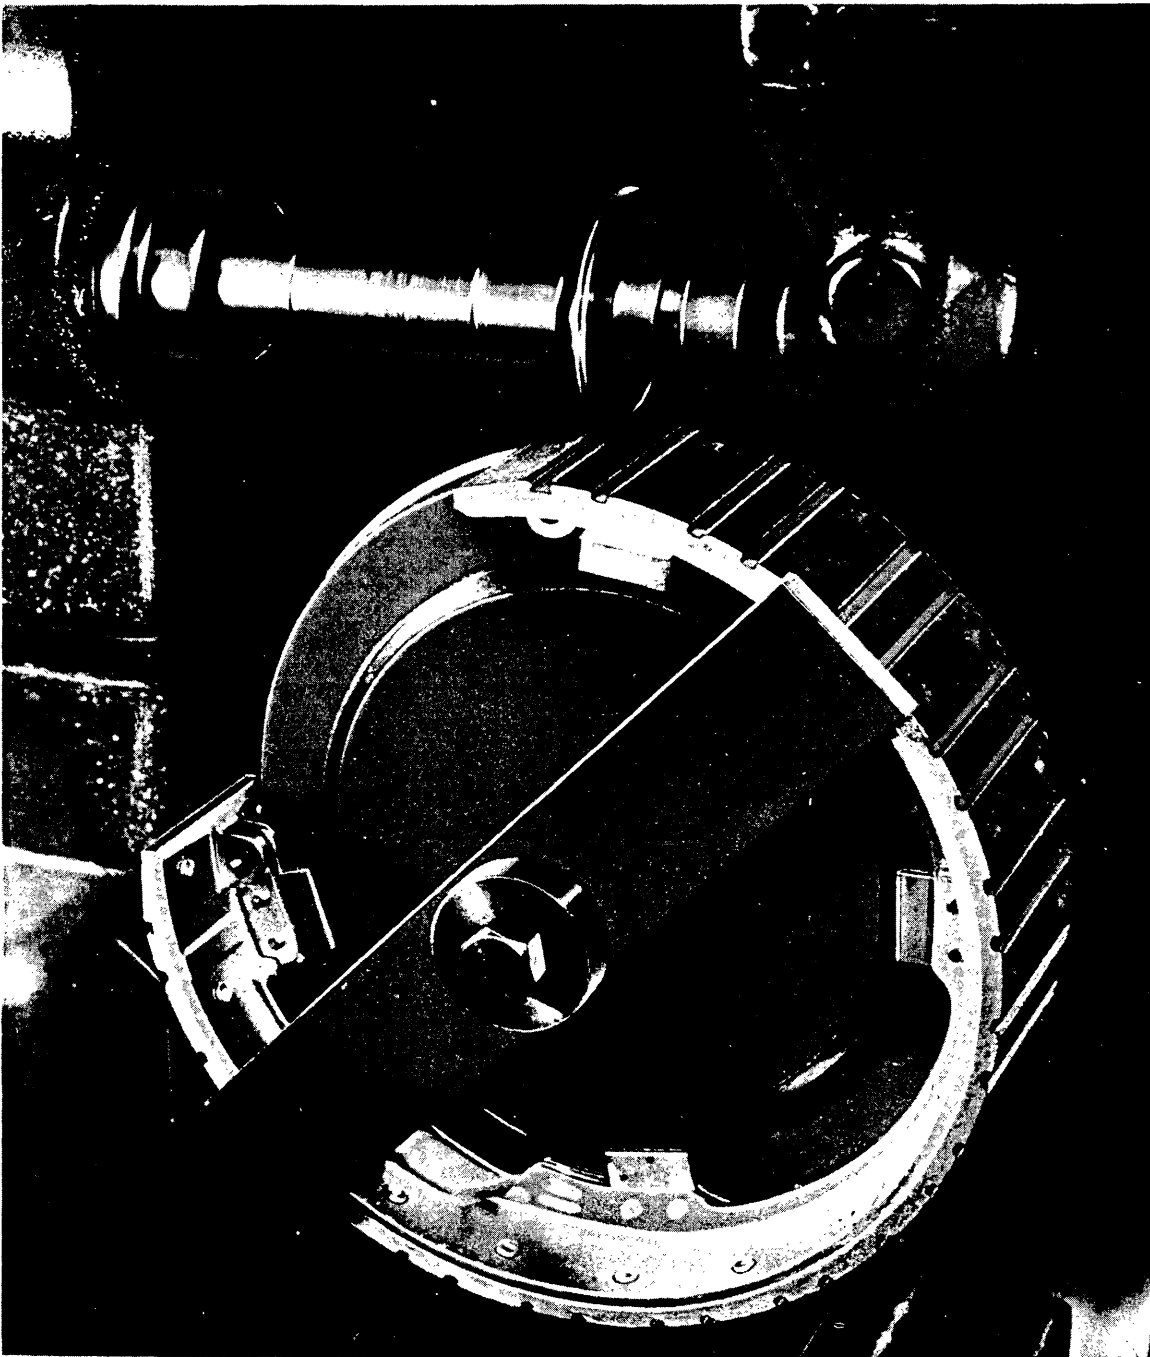
Figure 5 - A  
Completed  
Brake Lining

f. Repeat the procedure outlined in paragraph 2.e. preceding until the entire lining has been grooved in accordance with the markings on the lining. (See figure 5.)
